# **Long-Term Performance of Concrete Overlay US-1 Florida Case Study**

**Abdenour Nazef, P.E.**

**2015 RPUG Conference  
Raleigh, NC**

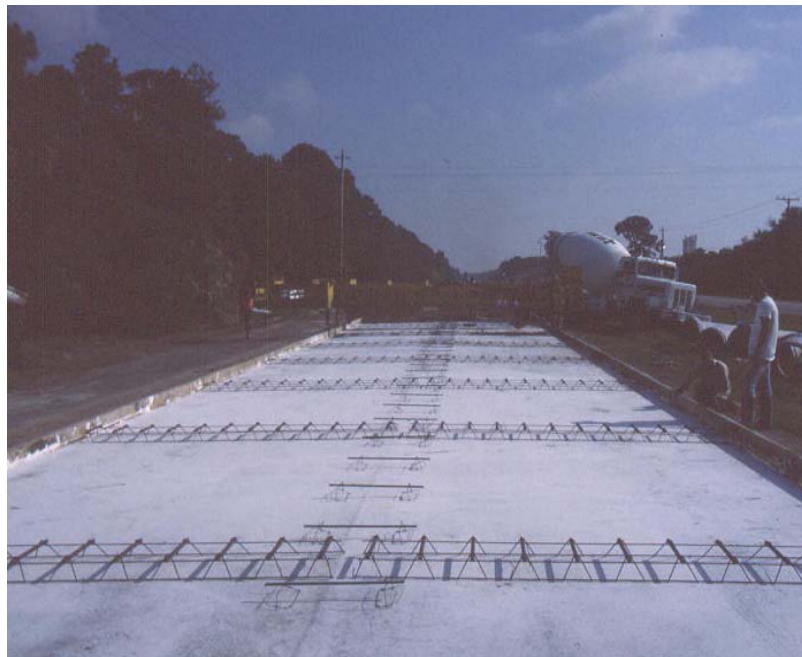
*Standard (ST)*

- *Dowel-bar configuration:*

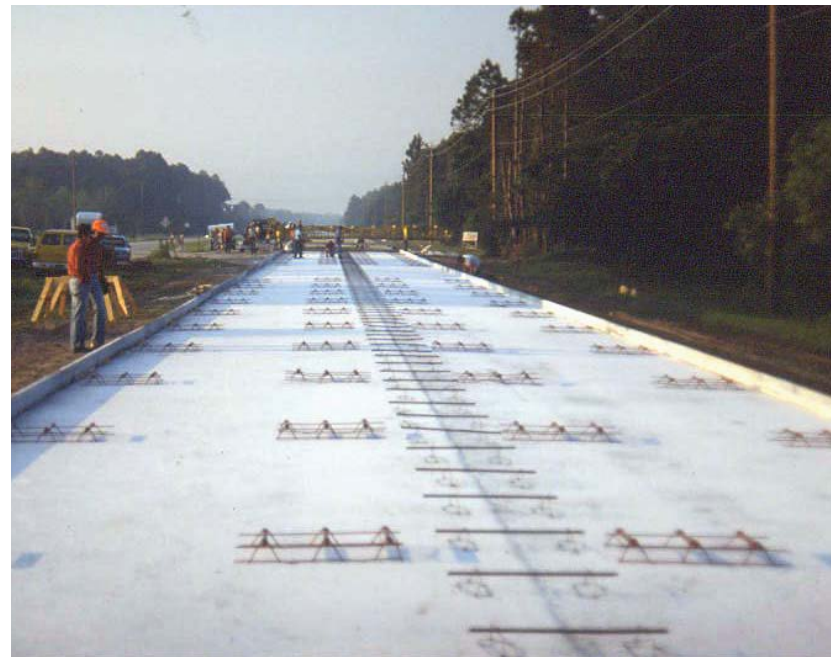
*Special (SP)*

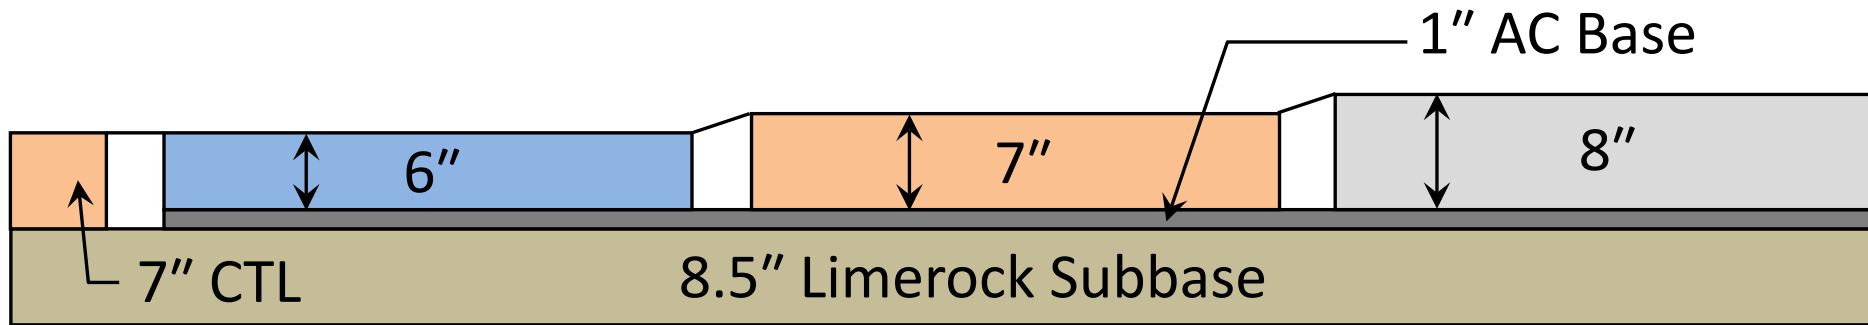
- Section ID

0	1	2	3	4	5	6	7	8	9	10	11	12	13	14	15	16	17	18
---	---	---	---	---	---	---	---	---	---	----	----	----	----	----	----	----	----	----

- Slab thickness

14	12	14	16	12	14	16	14	16	18	14	16	18	16	18	20	16	18	20
----	----	----	----	----	----	----	----	----	----	----	----	----	----	----	----	----	----	----

- Dowel-bar configuration

St	Sp	St	Sp	St	Sp	St
----	----	----	----	----	----	----

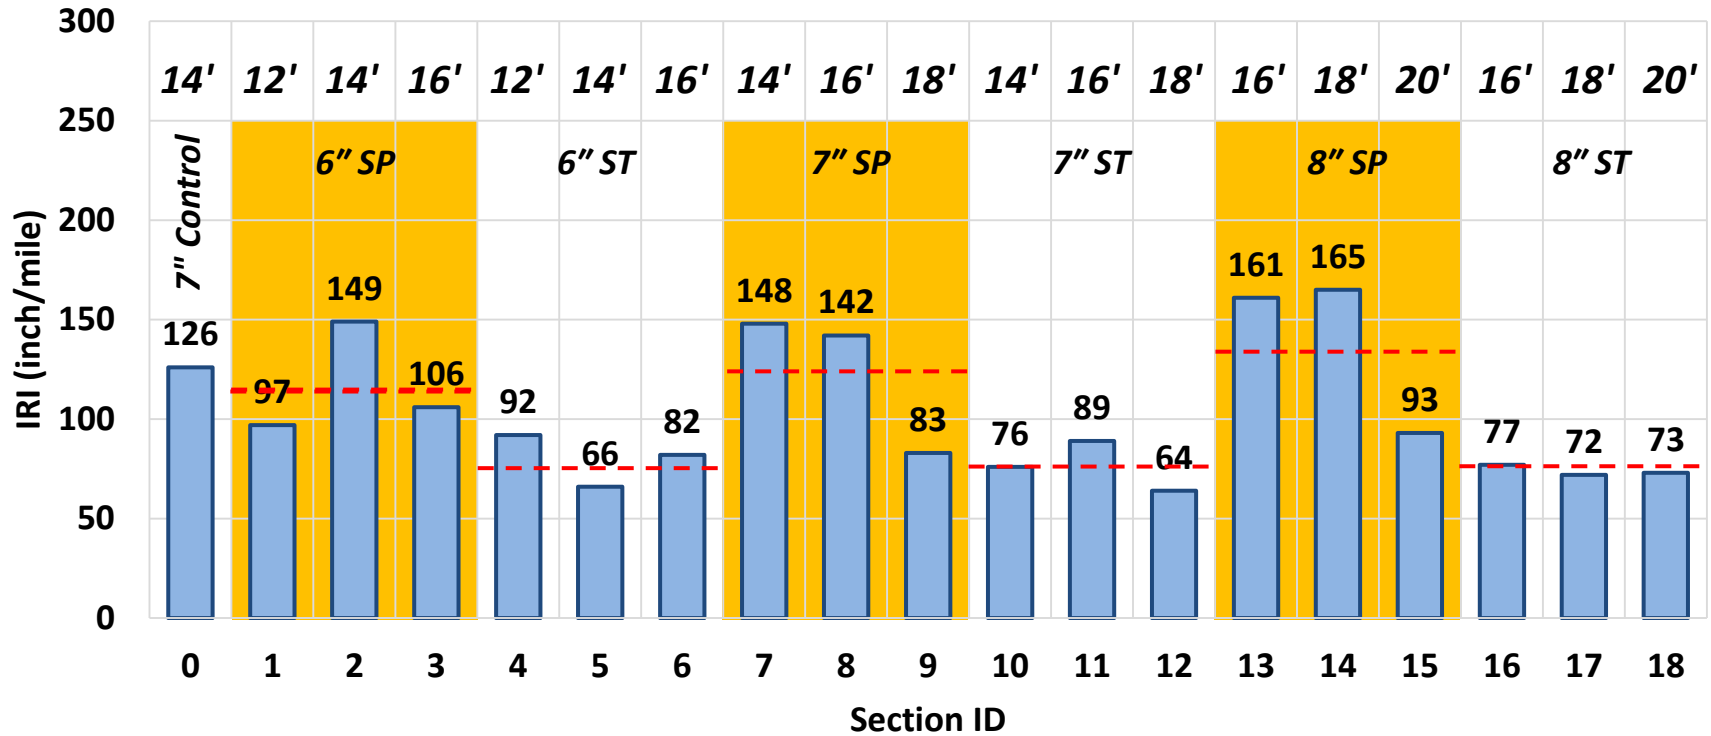
# Smoothness

Slab Thickness (in)	Dowel Config.	Joint Spacing (ft)	Average IRI (in/mile)	IRI Difference
6	SP	12 - 16	117	37
	ST		80	
7	SP	14 - 18	124	48
	ST		76	
8	SP	16 - 20	140	66
	ST		74

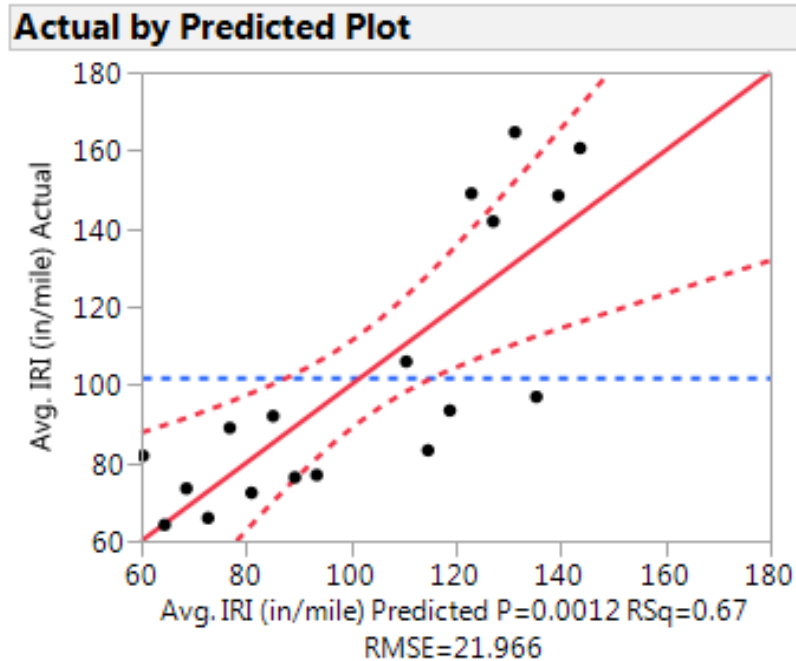
**Parameter Estimates**

Term	Estimate	Std Error	t Ratio	Prob> t
Intercept	85.346111	45.1354	1.89	0.0795
Length	-6.210833	3.170488	-1.96	0.0703
Dowel[Spe]	25.123333	5.177385	4.85	0.0003*
Thick	16.575	8.967494	1.85	0.0858

✓ **Dowel-bar configuration has the most significant effect on smoothness**

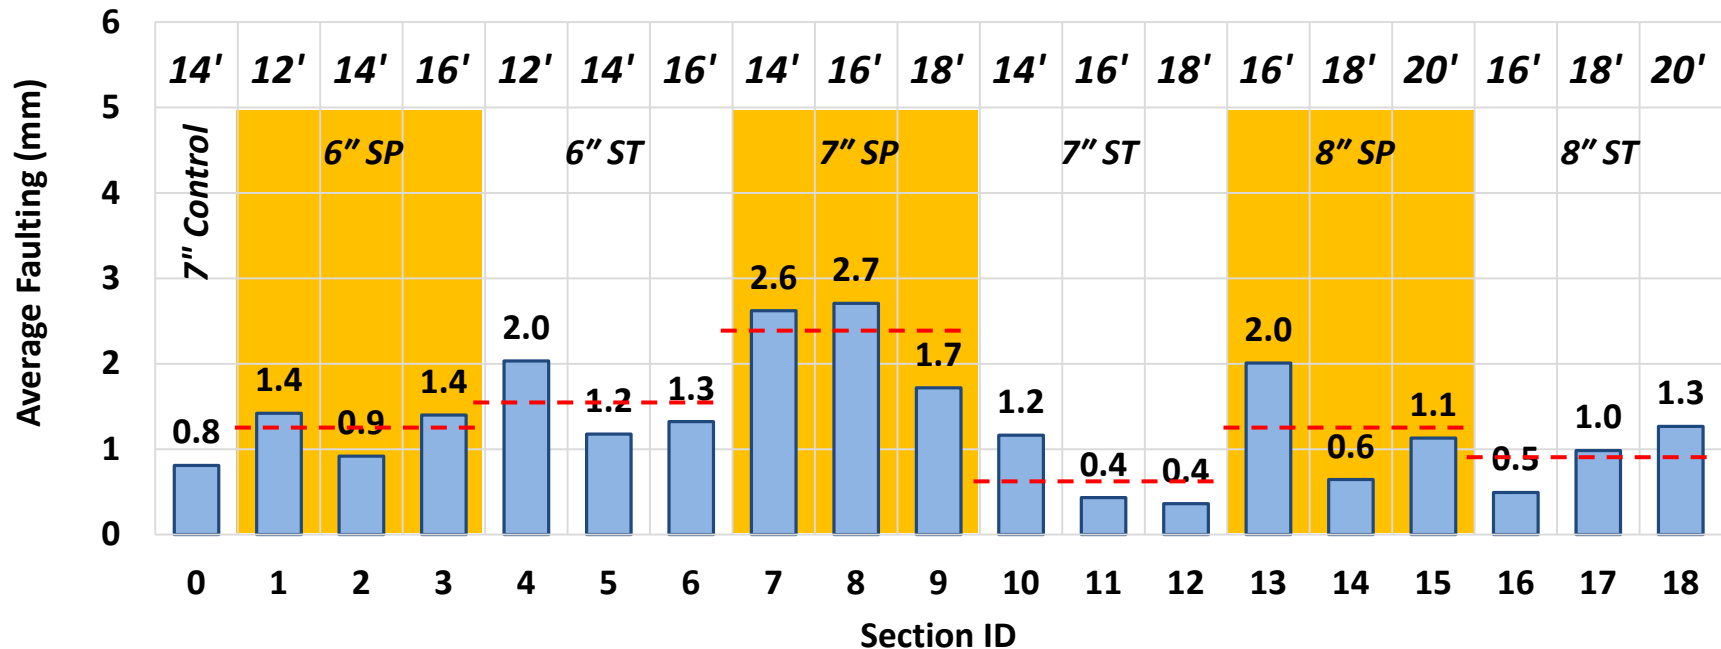
# Faulting

✓ Slabs with special dowel bar configuration have relatively higher faulting

Slab Thickness (in)	Dowel Config.	Joint Spacing (ft)	Average Faulting (mm)	Faulting Difference
6	SP	12 - 16	1.3	0.3
	ST		1.0	
7	SP	14 - 18	1.5	0.6
	ST		0.9	
8	SP	16 - 20	1.4	0.5
	ST		0.9

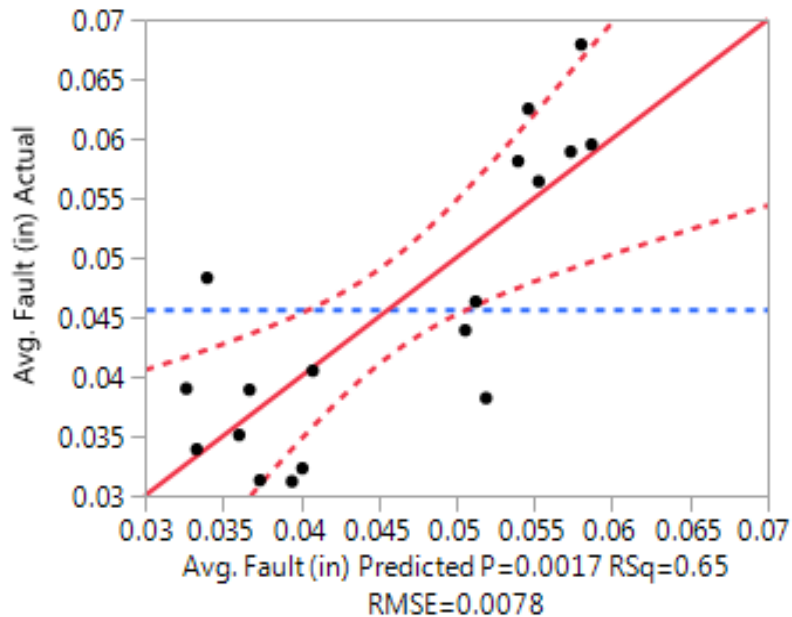
Actual by Predicted Plot

Term	Estimate	Std Error	t Ratio	Prob> t
Intercept	0.0537361	0.016054	3.35	0.0048*
Length	-0.001696	0.001128	-1.50	0.1548
Dowel[Spe]	0.0089556	0.001841	4.86	0.0003*
Thick	0.002725	0.00319	0.85	0.4073

✓ **Dowel-bar configuration has the most significant effect on faulting**

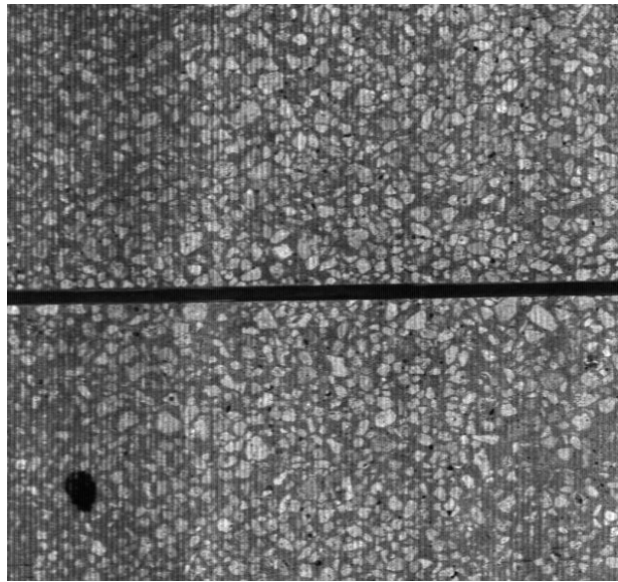
**Diamond Grinding**  
(standard in FL)

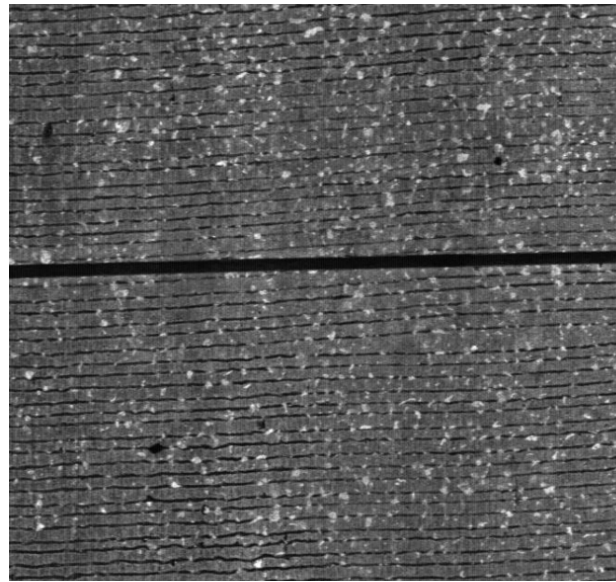
**Transverse Tining**

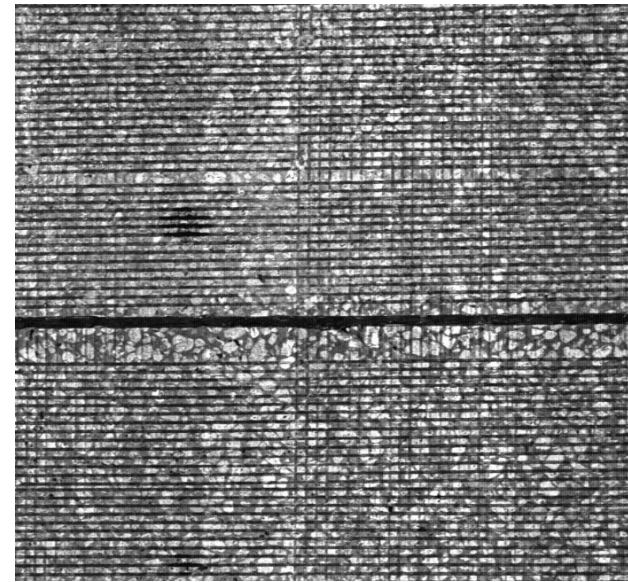
**“Two-Way” Diamond Grinding** (atypical)

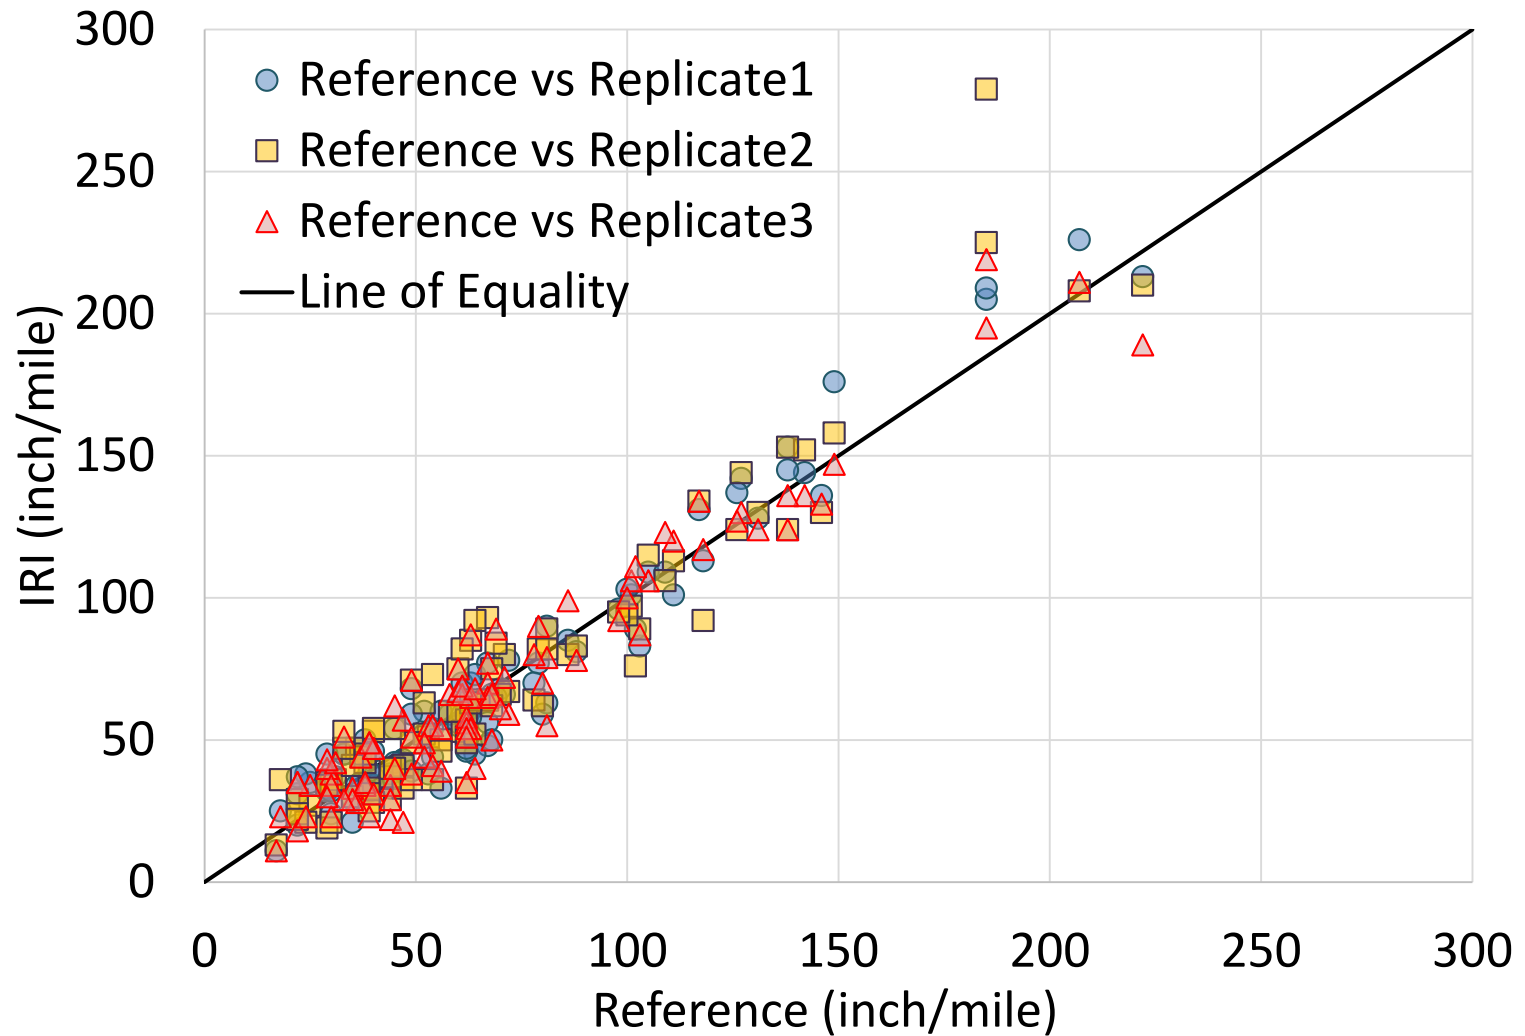
# Single Spot Repeatability

<i>Sensor</i>	<i>IRI (in/mile)</i>				
	<i>Run 2</i>	<i>Run 3</i>	<i>Run 4</i>	<i>Run 5</i>	<i>Average</i>
<i>Single Spot</i>	95.1	95.8	95.7	95.2	95.5
<i>Wide Spot</i>	95.9	96.3	96.4	96.1	96.2
<i>Roline</i>	94.0	94.1	94.6	94.2	94.2

<i>Sensor</i>	<i>Repeatability Cross Correlation (%)</i>		
	<i>Min.</i>	<i>Max.</i>	<i>Average</i>
<i>Single Spot</i>	93.0	95.9	95.0
<i>Wide Spot</i>	96.6	97.9	96.6
<i>Roline</i>	94.9	97.4	95.8

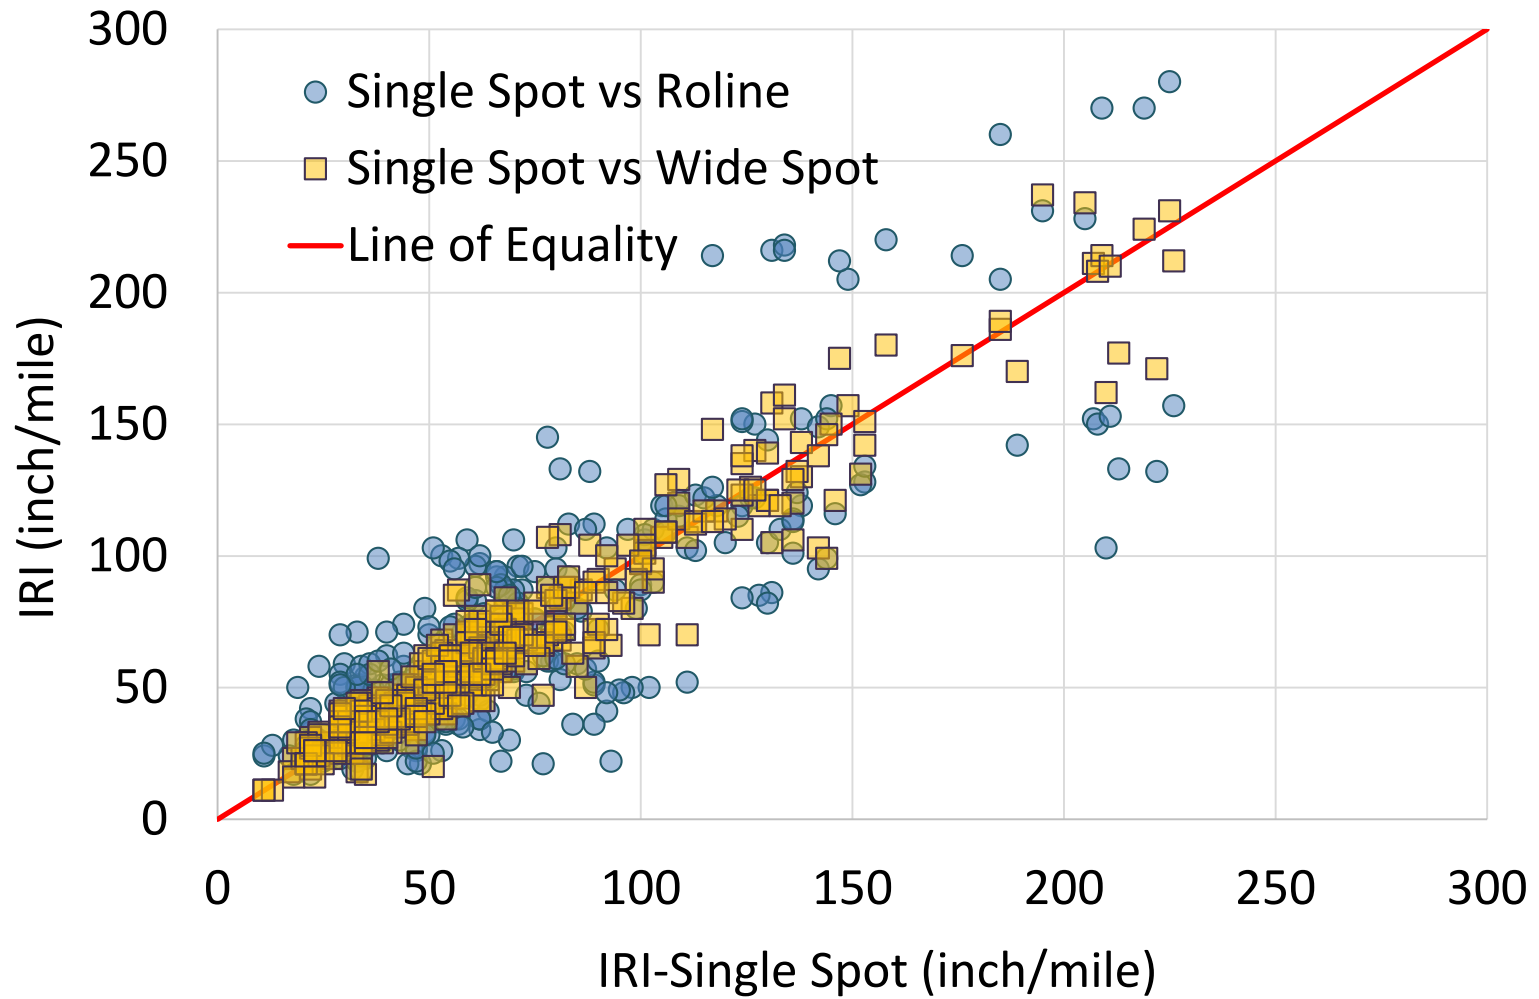
# Sensor "Reproducibility"

<b><i>Correlated Sensors</i></b>	<b><i>Reproducibility Cross Correlation (%)</i></b>
<b><i>Single Spot vs Wide Spot</i></b>	93.3
<b><i>Single Spot vs Roline</i></b>	94.9
<b><i>Wide Spot vs Roline</i></b>	93.8

- *For smoothness ...*
  - ✓ *All three lasers correlate strongly*
