LCMS - 3D road scanning and texture

Vision Technology for Inspection of Transportation Infrastructures

Application: ROADS distress and DTM

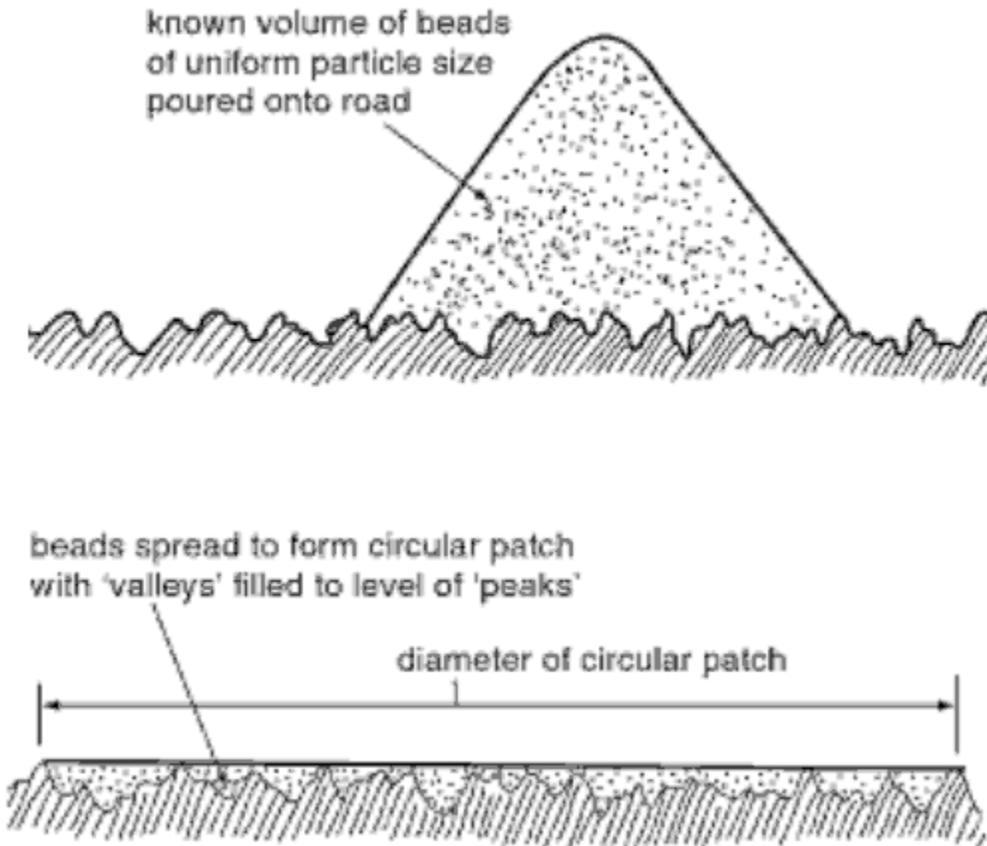
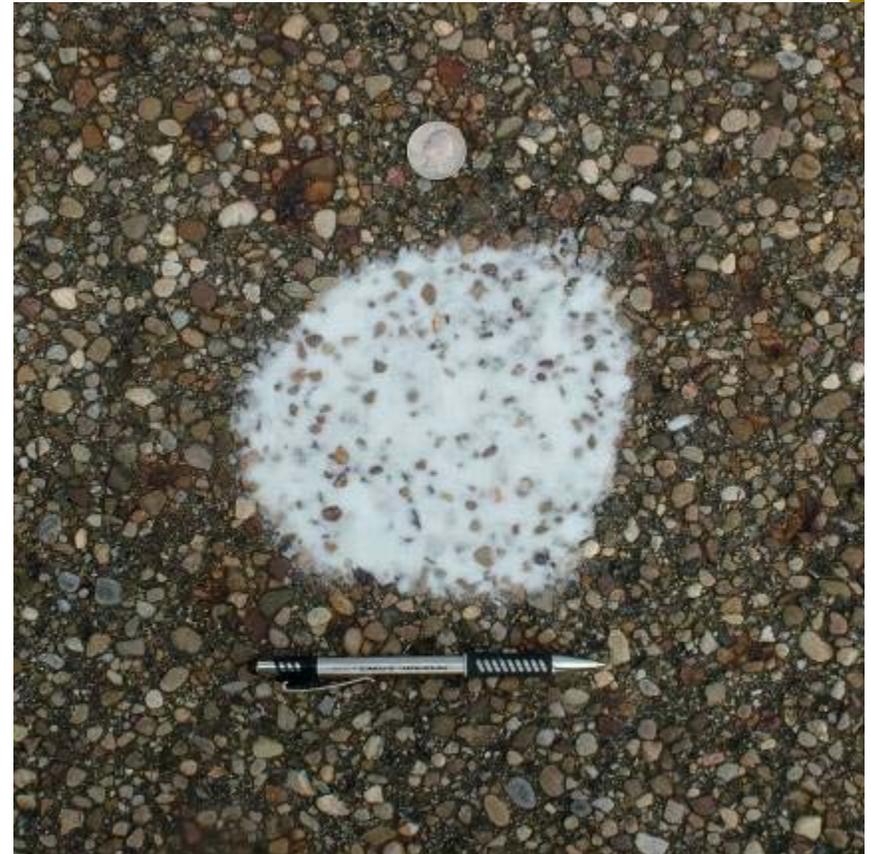
Sand patch method (MTD) (ASTM E965)

Sand patch method (MTD) = Volume of sand (fixed) divided by diameter measured (surface area)

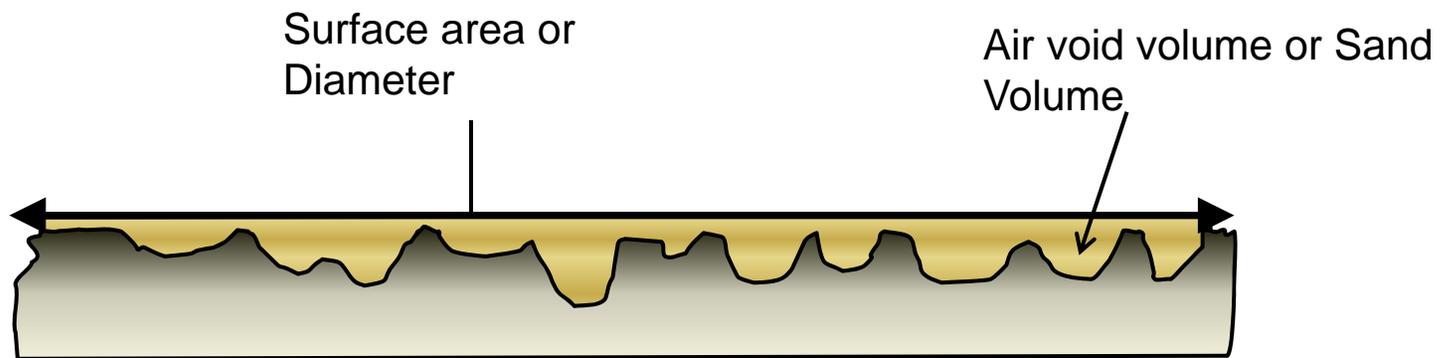
Sand patch method (MTD) (Automated)

Automatic method MTD = Air void volume measured divided by a fixed surface area (approx square foot, 25x25 cm)

$$\text{MTD} = \frac{(\text{Volume}_{\text{air void}})}{\text{Surface Area}}$$

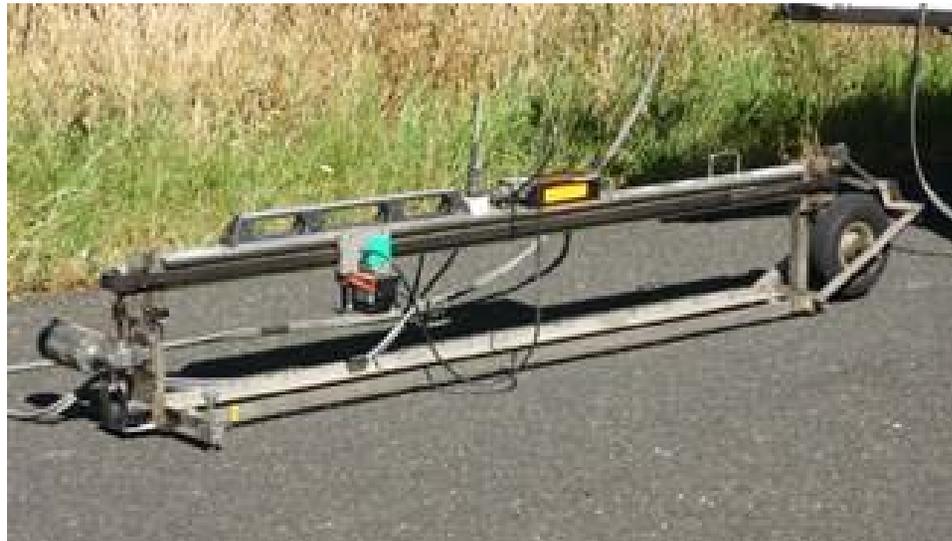
NZTA – Macro-texture validation with SLP

- Reference device is a SLP (Stationary Laser Profiler) used by New Zealand Transit Authority
- The SLP uses a 32kHz Selcom® laser with a spot size of 0.5 mm to take a profile measurement every 0.3 mm.
- The laser traverses along a 1.67m track by a drive from a toothed belt.
- It was laid end to end throughout the texture validation sites to provide the reference texture measurements (MPD).
- To compare with LCMS texture the SLP results were converted using $MTD = 0.8 * MPD + 0.2$

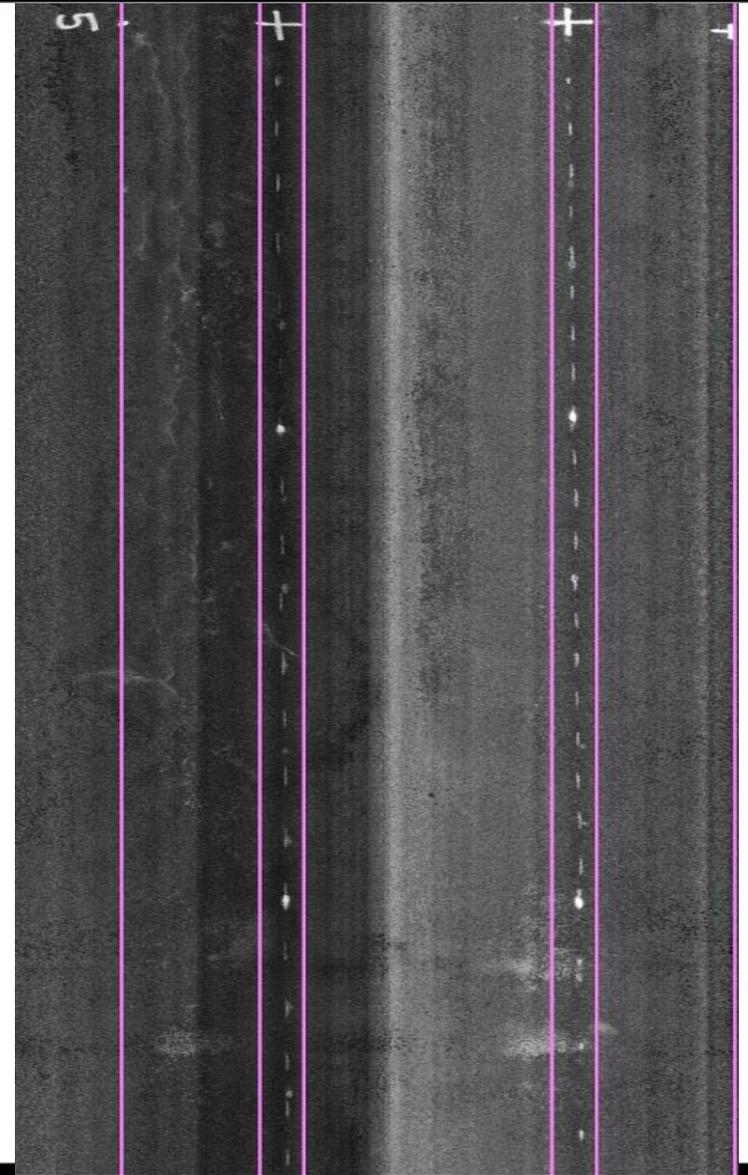
NZTA – Macro-texture validation with SLP

- 7 different survey sites in New Zealand.
- The length of each survey site is 200m (except site V07 which is 300m).
- Texture range from 0.4mm (MPD) to 3.5mm (MPD)
- Multiple runs of LCMS data were collected on each survey site, at different speeds (30km/h, 50km/h and 80km/h).
- The SLP measurement paths are marked with paint. This is the transversal position where the SLP device measures the texture.
- The SLP device outputs one MPD value every 10cm, for each wheel path

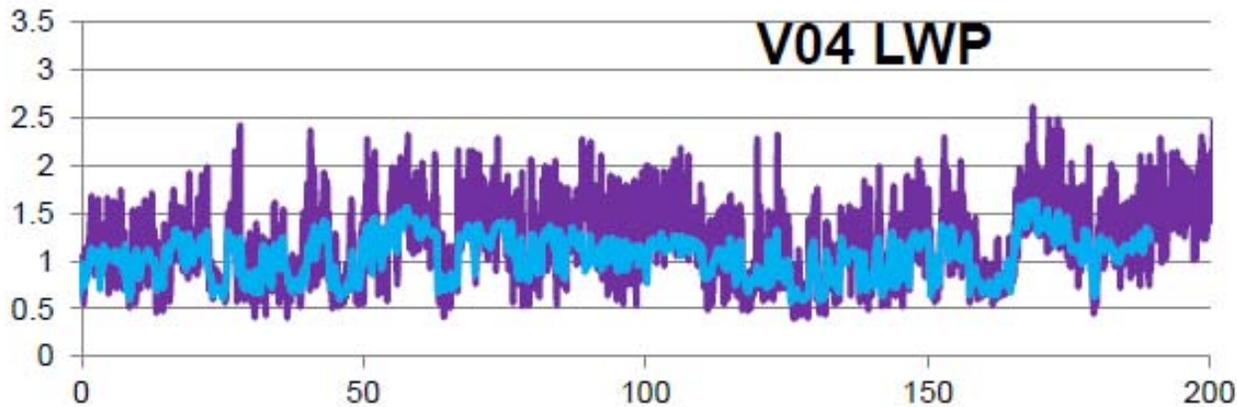
SLP vs LCMS(MTD unfiltered)

— LWP MTD (SLP)
— LWP V04504 MTD (LCMS)

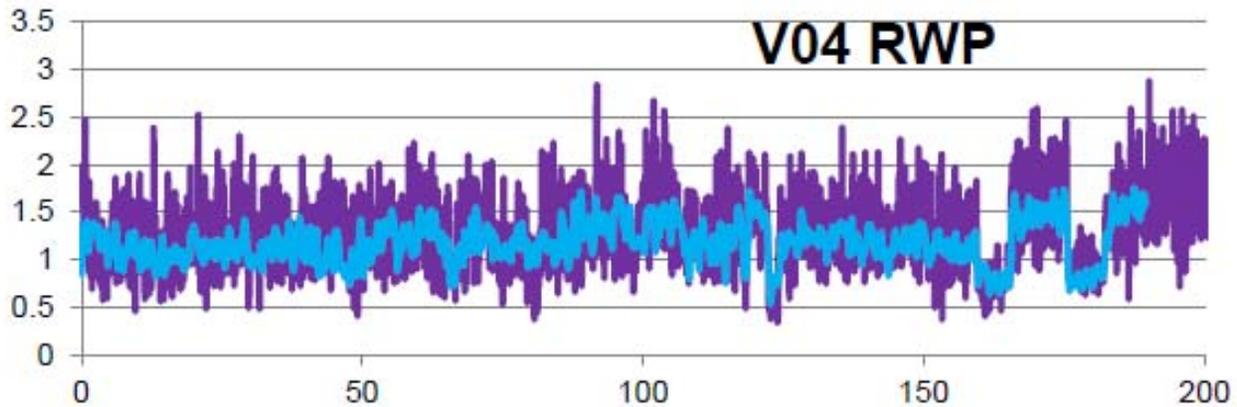
— RWP MTD (SLP)
— RWP V04504 MTD (LCMS)

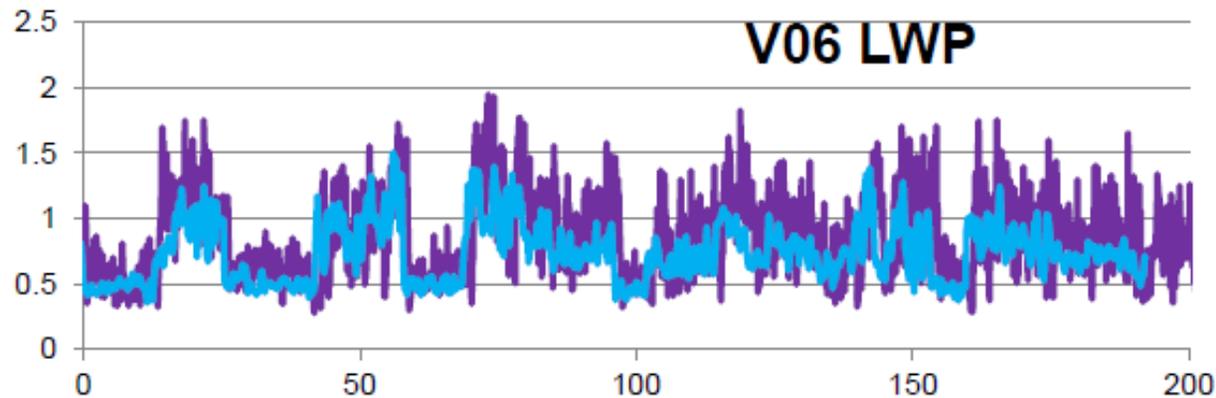
— LWP MTD (SLP)
— LWP V06504 MTD (LCMS)

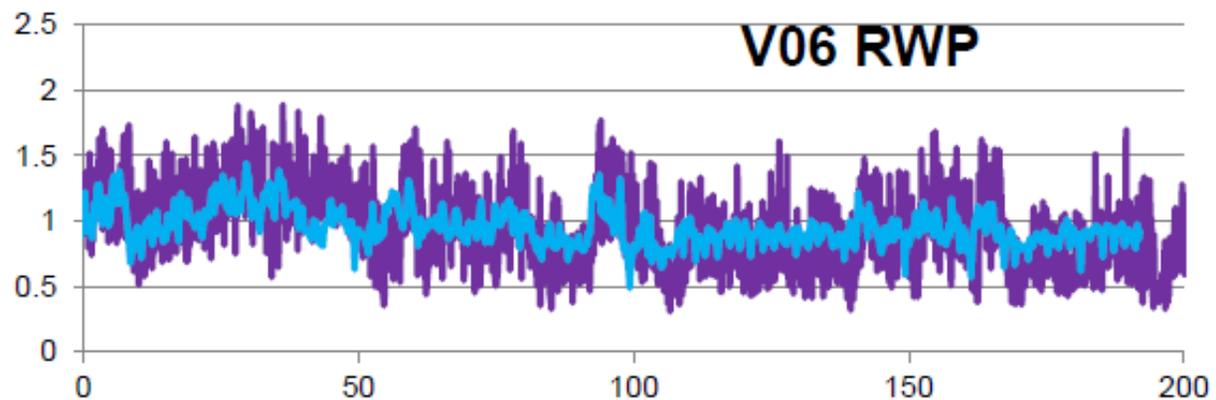
— RWP MTD (SLP)
— RWP V06504 MTD (LCMS)

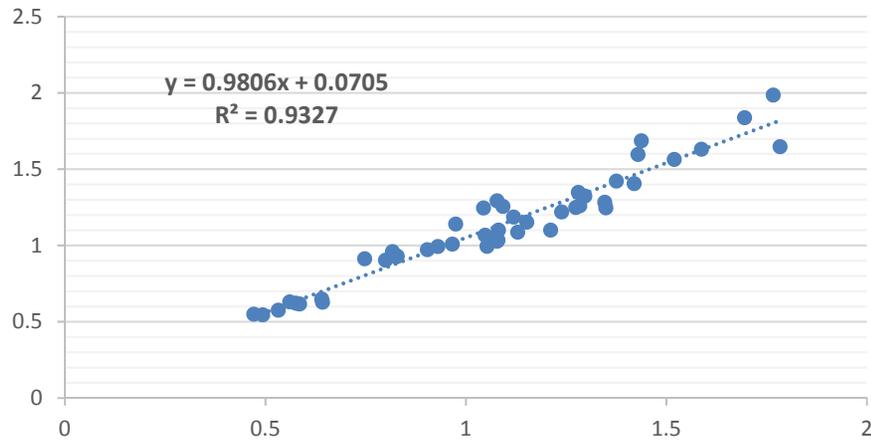
SLP MTD RIGHT vs LCMS MTD RIGHT 30 KM/H

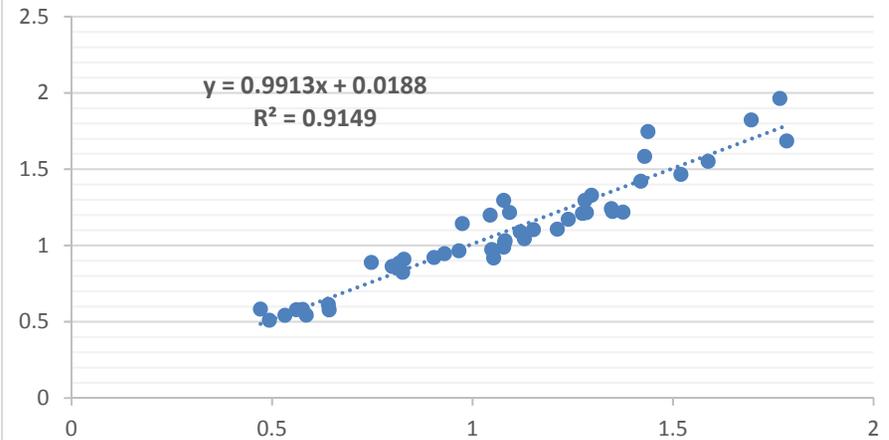
SLP MTD RIGHT vs LCMS MTD RIGHT 50 KM/H

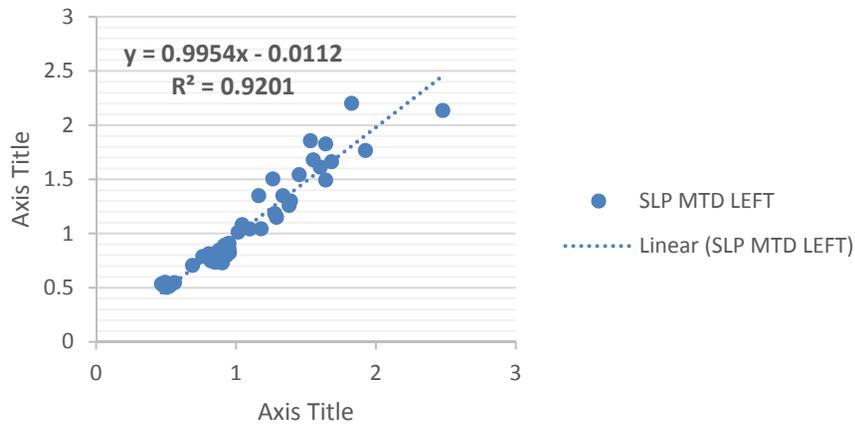
SLP MTD LEFT vs LCMS MTD 30 km/h LEFT

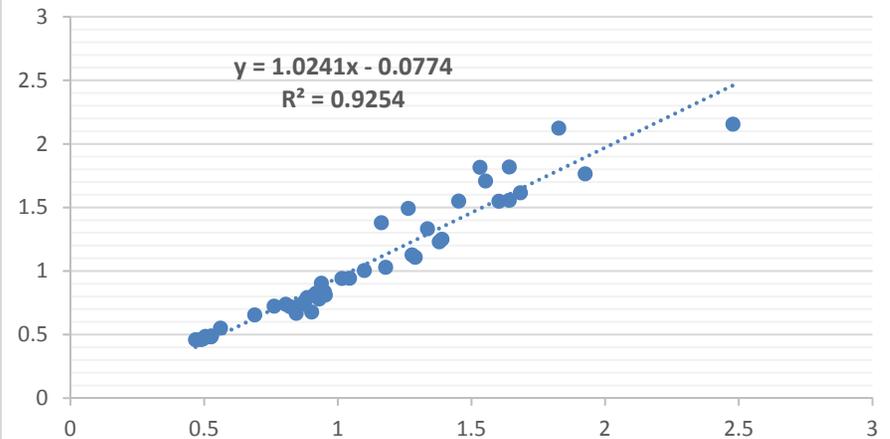
SLP MTD LEFT vs LCMS MTD LEFT 50 km/h

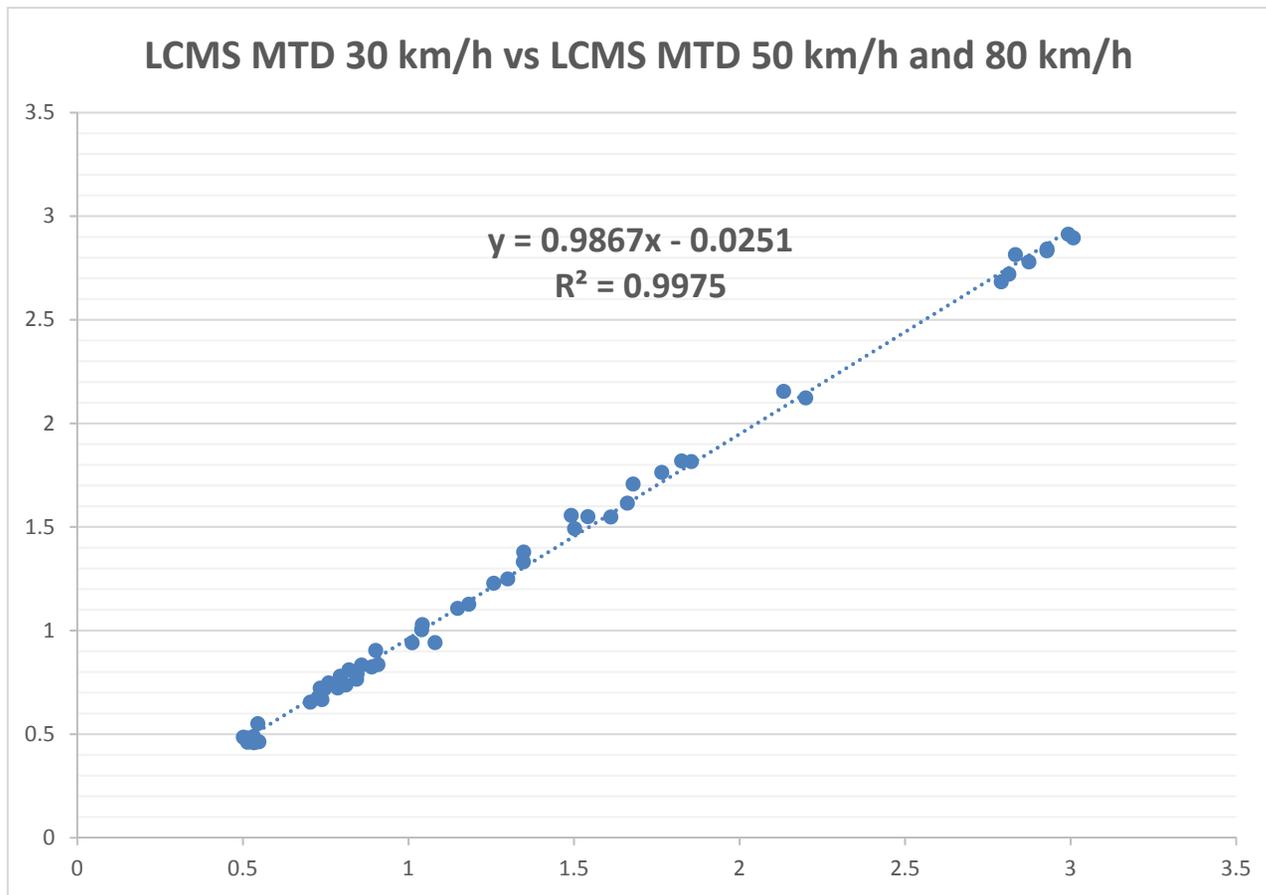
LCMS - Macro-texture (30km/h, 50km/h, 80km/h)

- 7 different survey sites in New Zealand measured with SLP.
- Texture range from 0.4mm (MPD) to 3.5mm (MPD)
- Multiple runs of LCMS data were collected at different speed (30km/h, 50km/h and 80km/h).
- The LCMS high speed texture measurements correlate very well (92%) with high accuracy ground truth from SLP.
- The repeatability of LCMS texture measurements when averaged over 25m correlate very well (99+%) between different runs even at different speeds (30km/h, 50km/h, 80km/h).

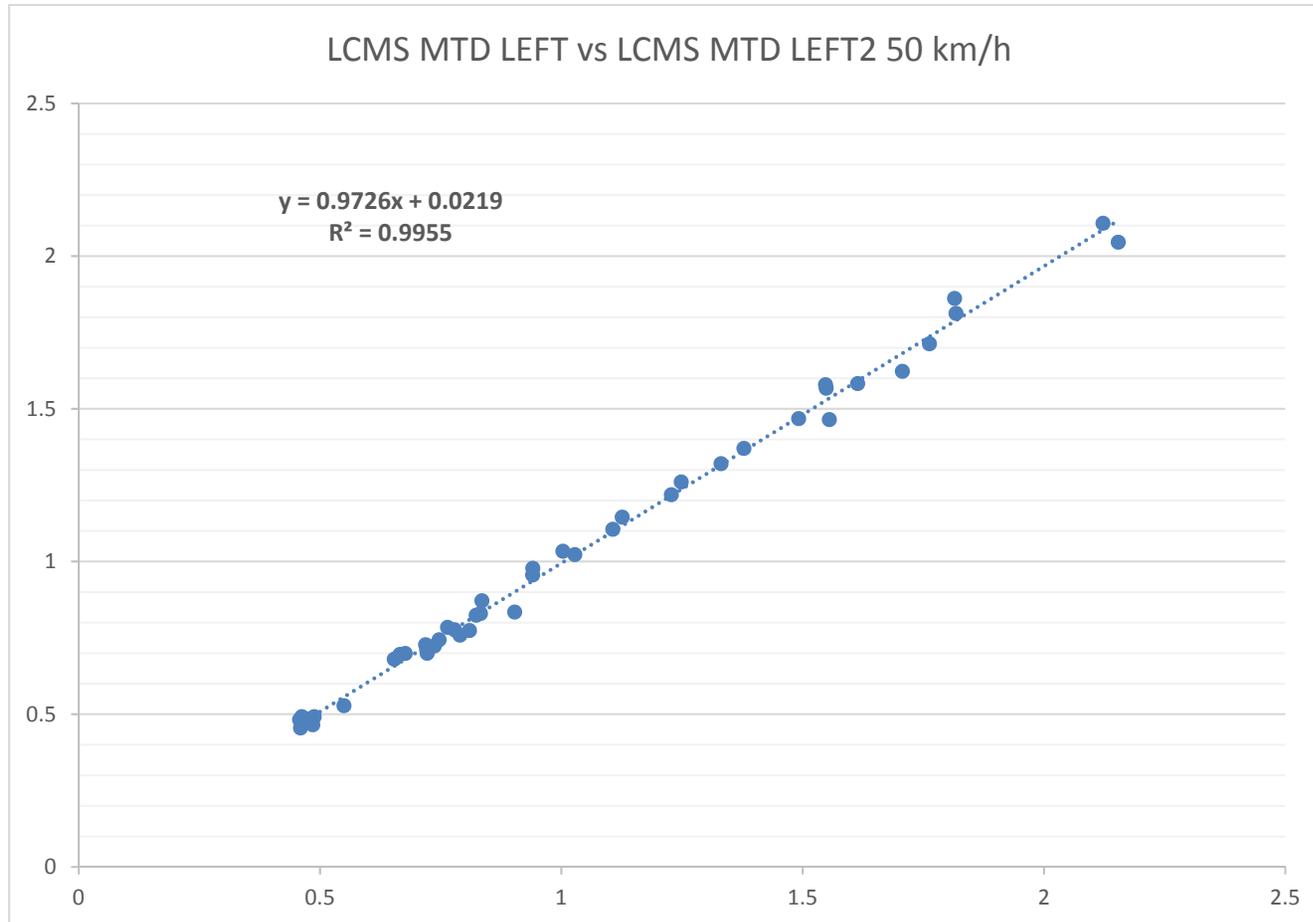
LCMS - MTD repeatability

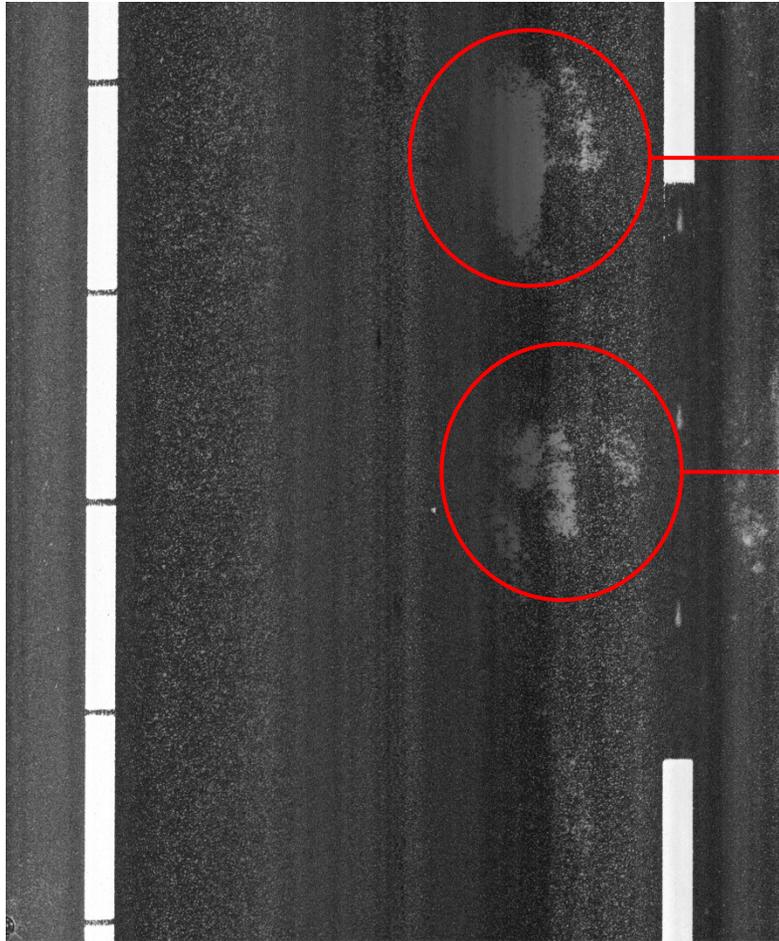
Macrotexture: bleeding

Intensity image

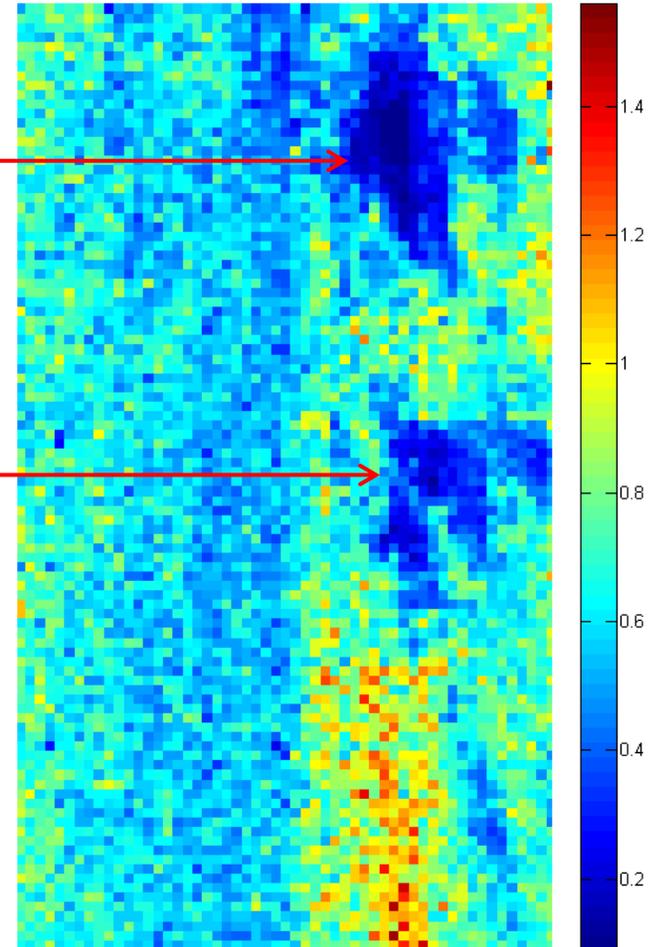
Texture image (MTD, mm)

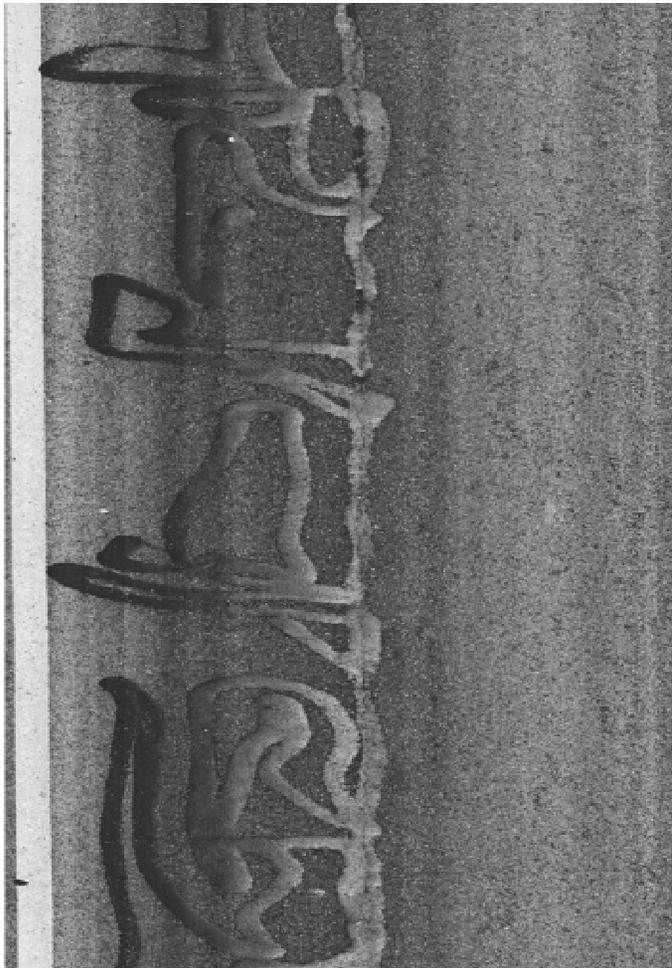
Intensity image (sealed cracks)

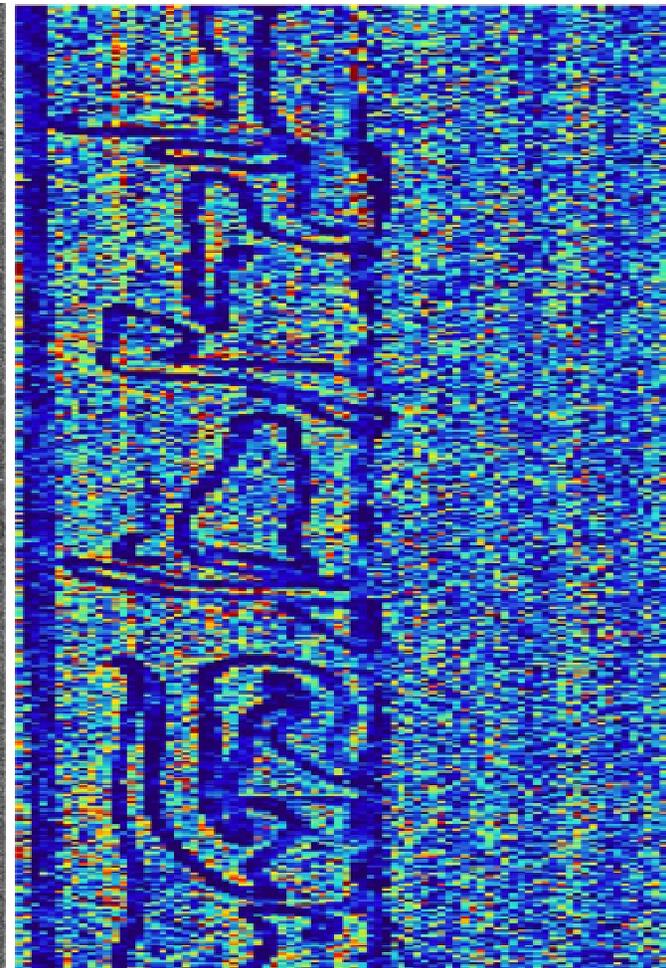
Texture image (sealed cracks)

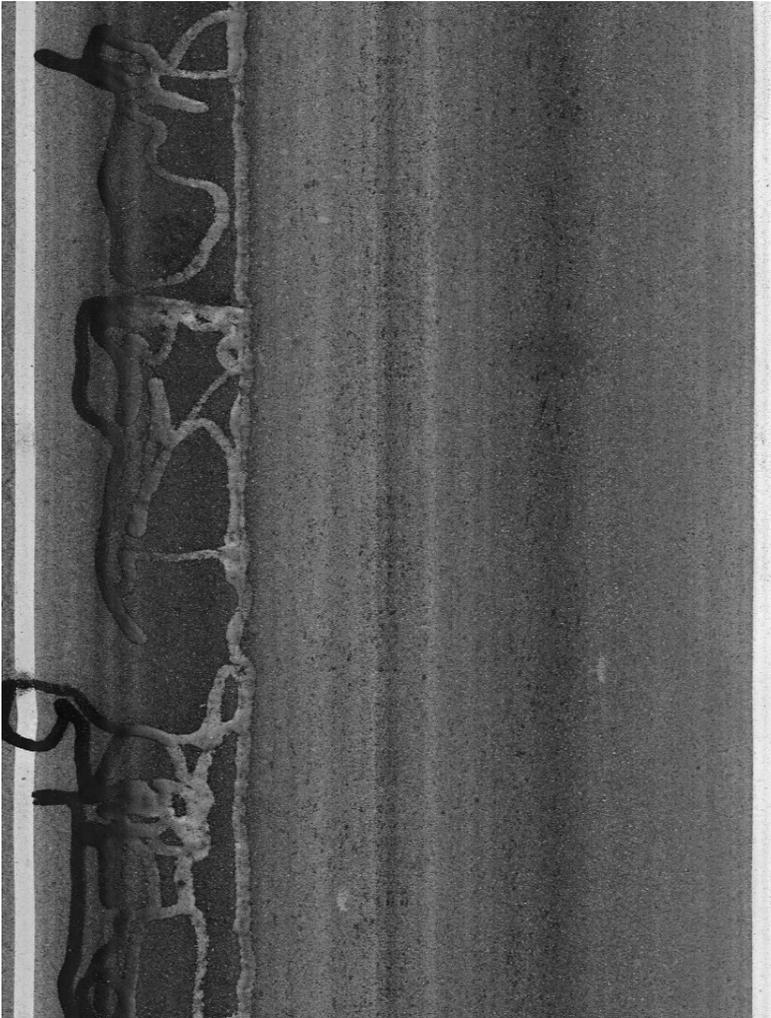
Example (white and dark sealed cracks)

Intensity image (sealed cracks)

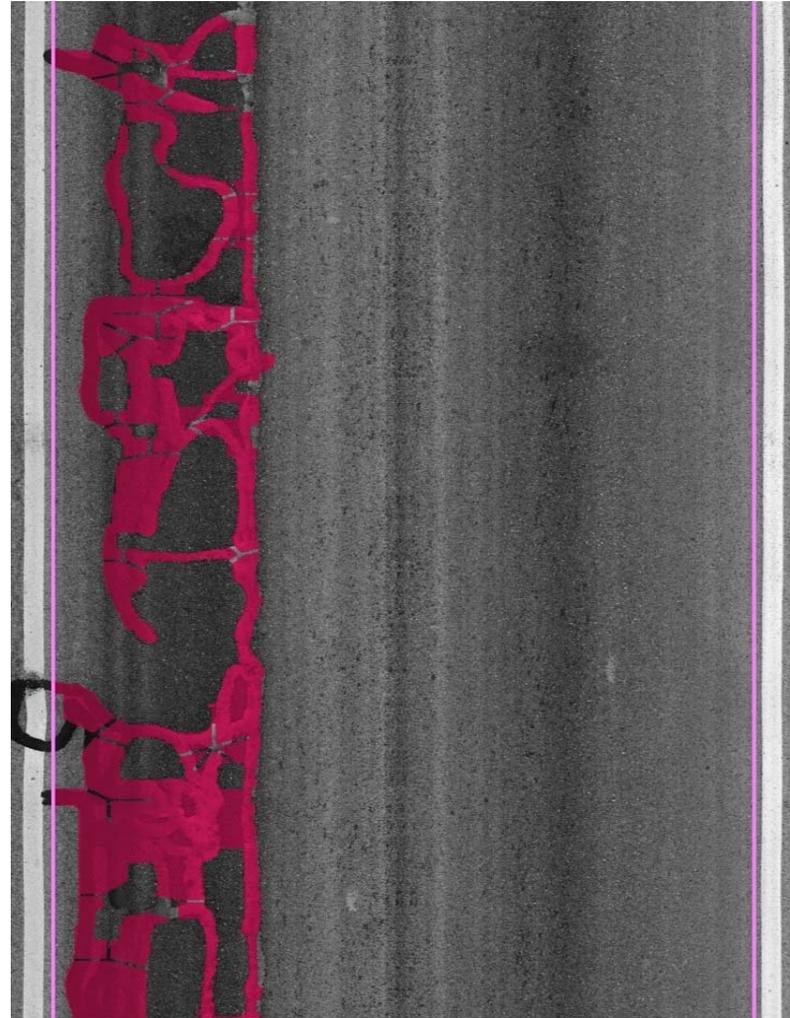
Detection image (sealed cracks)

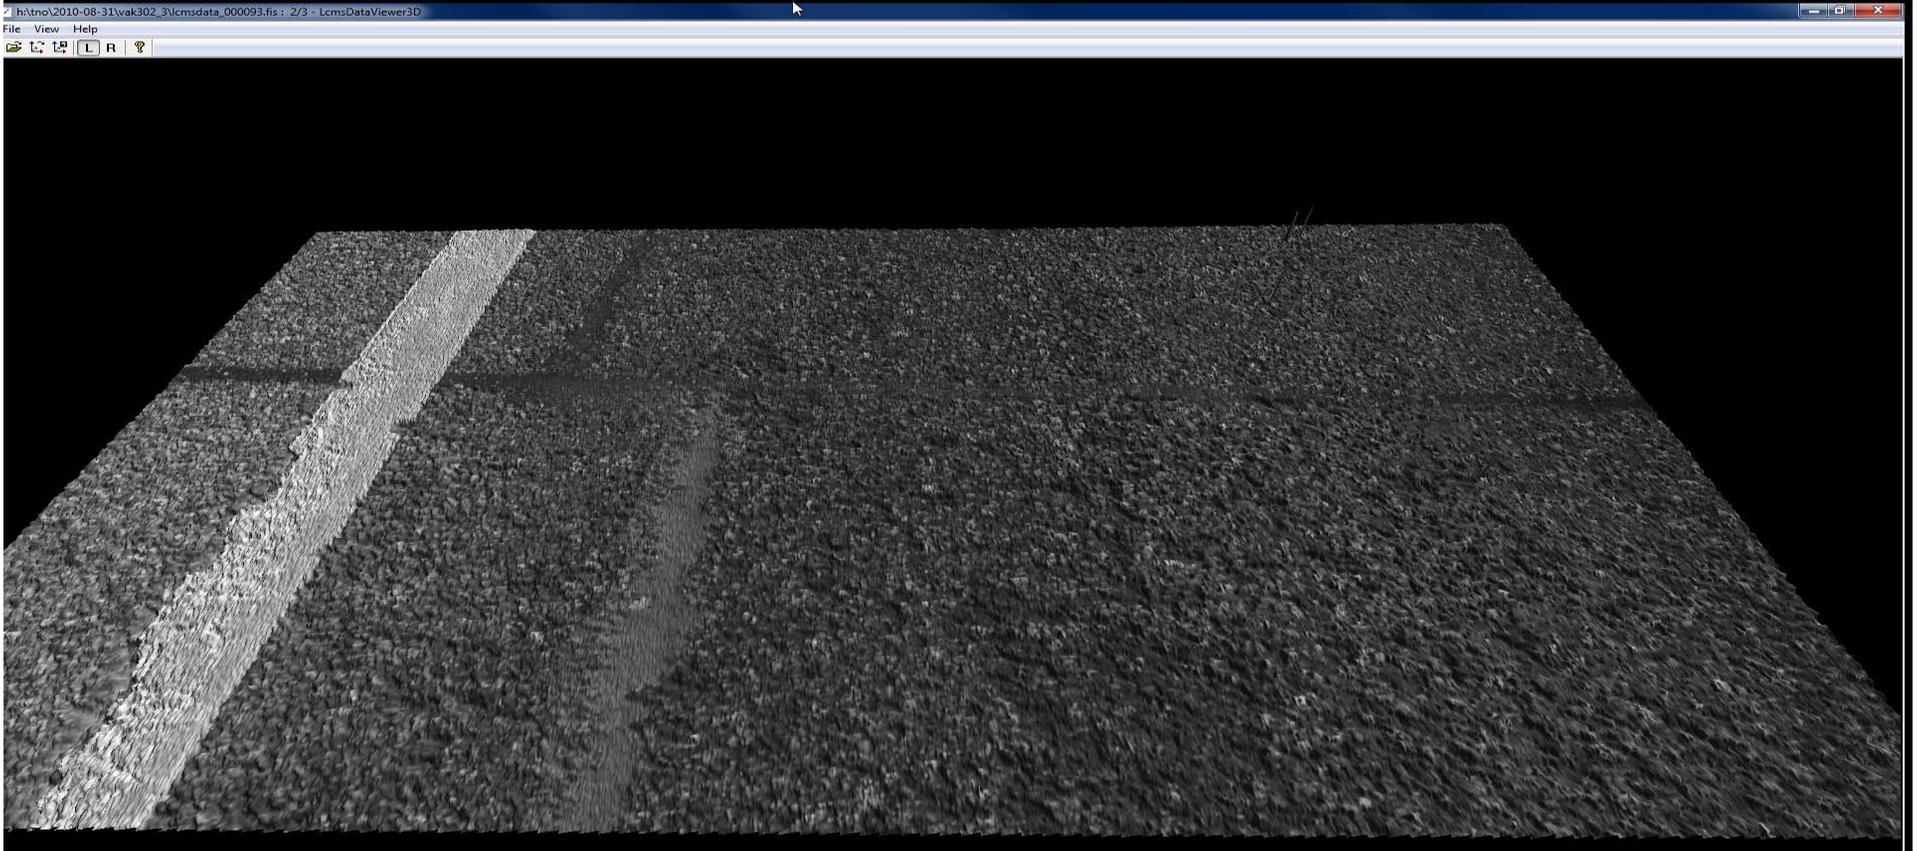
Ravelling – Loss of aggregate

Ravelling Index (RI) = The volume of aggregate loss per surface area

$$RI = V_{\text{aggregate loss}} / A_{\text{Total}}$$

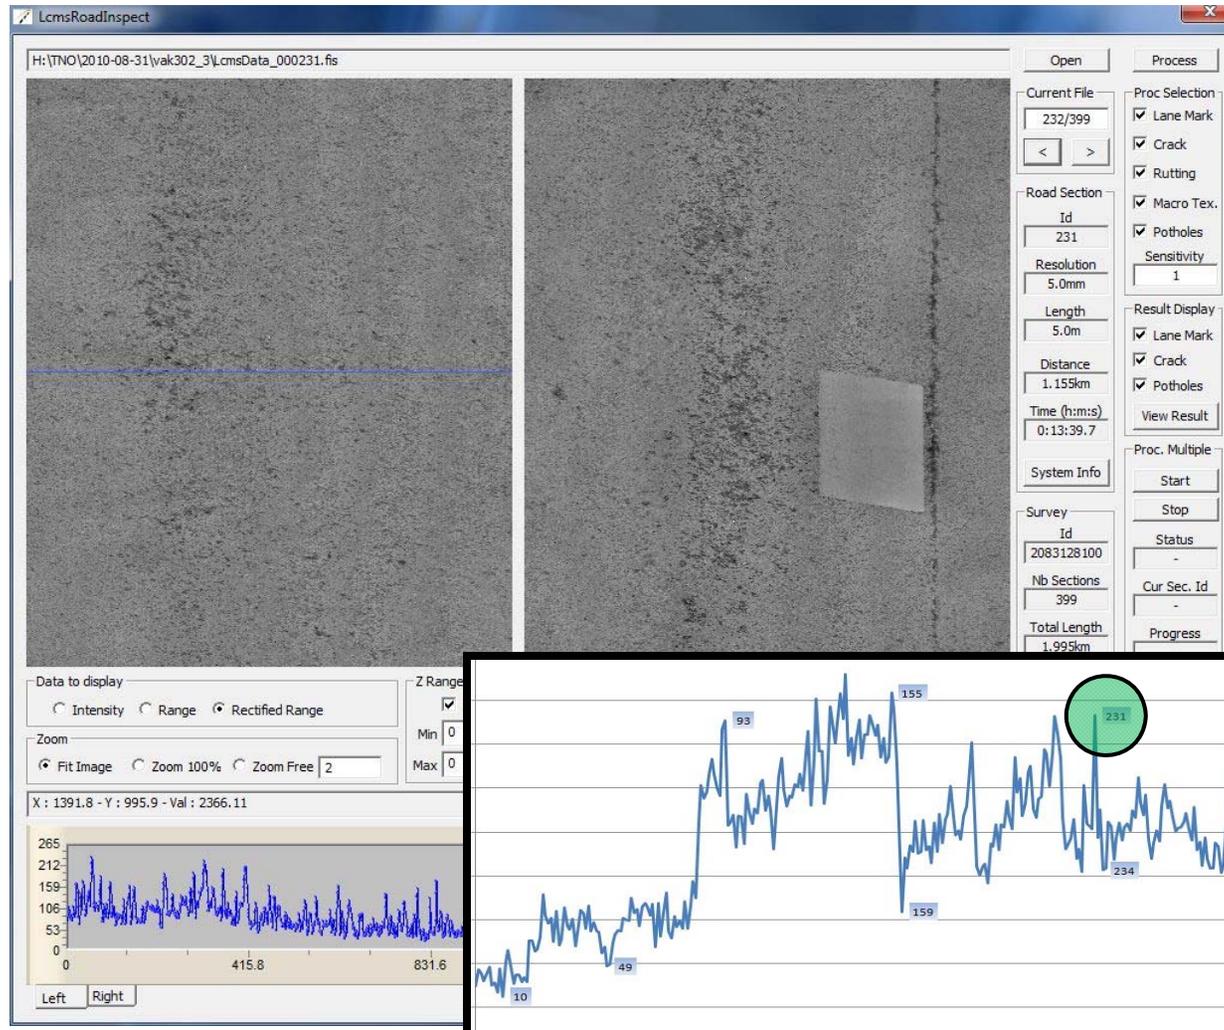
Road Section #231 : Raveling patch

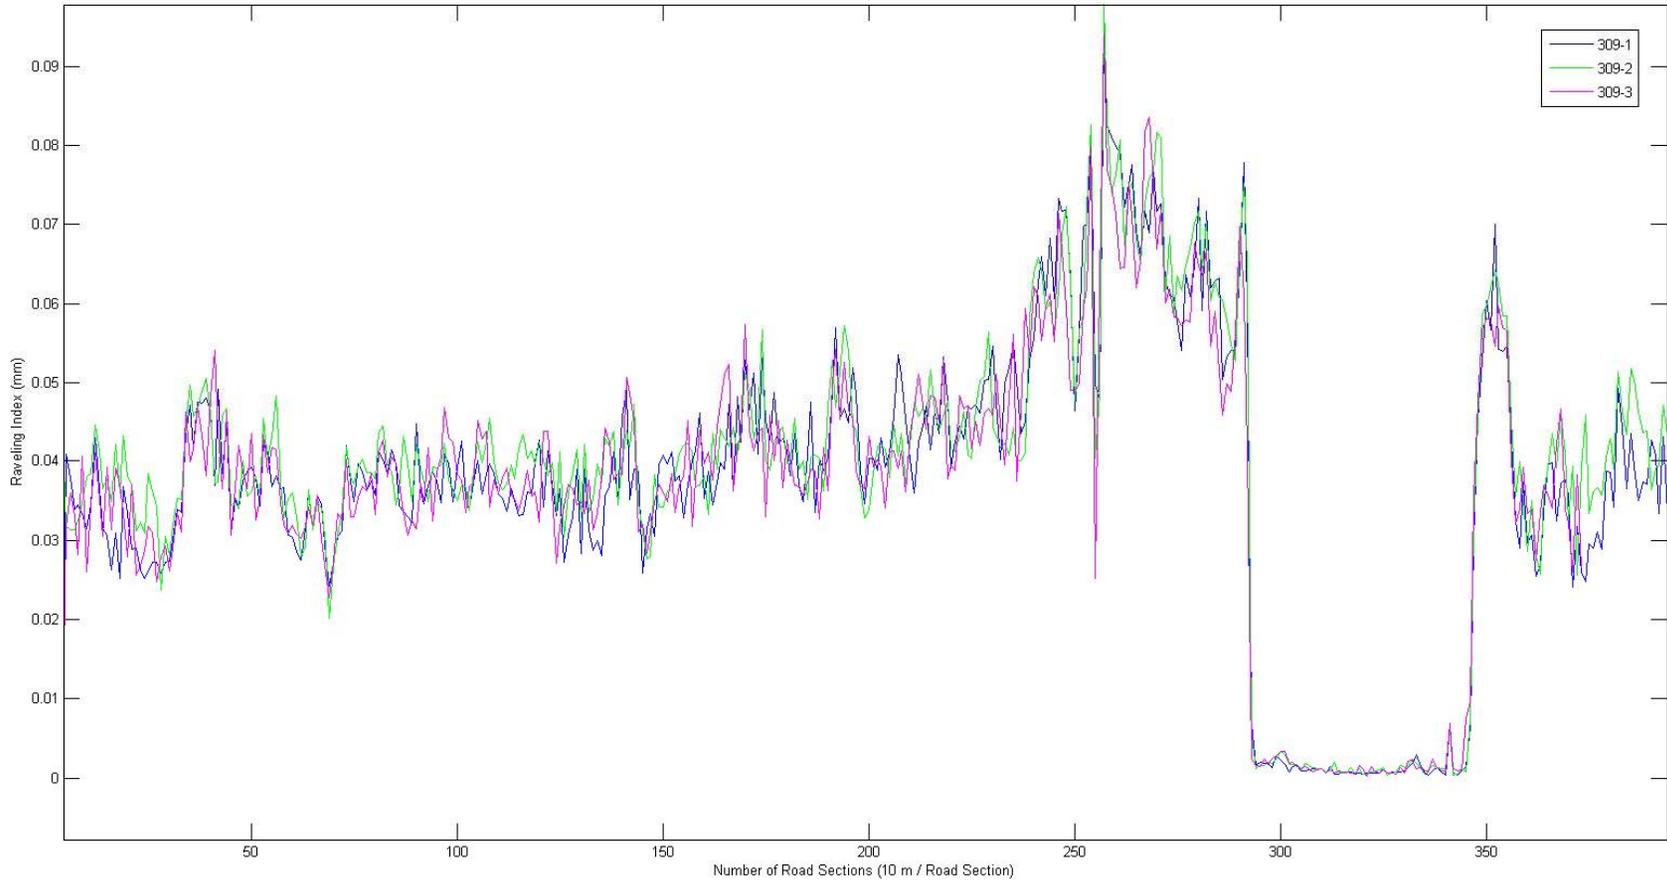
Ravelling Index - Repeatability (Porous asphalt Netherlands)

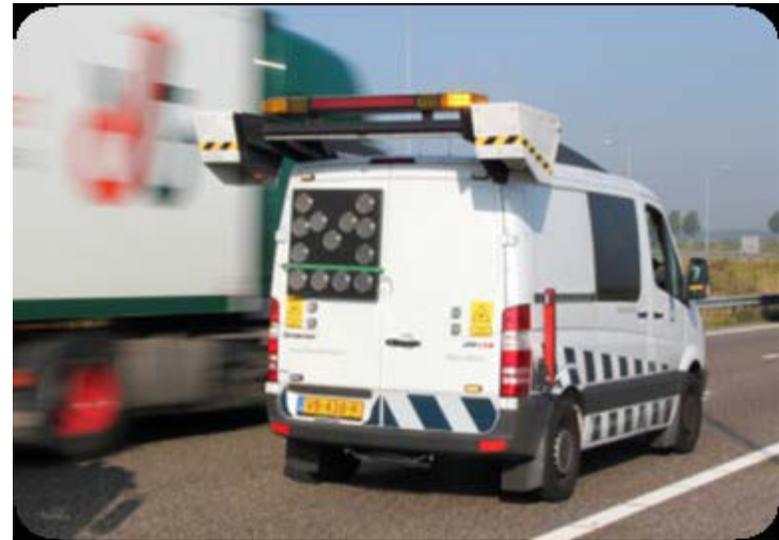
Rijkswaterstaat vehicle
