# Evaluation of Changes in IRI Along the Center of Lane to Assess the Effect of Environmental Factors on IRI

*Rohan Perera, PhD, PE  
SME, Plymouth, Michigan*

# Project Objective

- Evaluate changes in Center of Lane IRI (CLIRI) to assess impact of environmental effects on IRI for flexible pavements (Asphalt Concrete).
- Use data from LTPP SPS-1 Experiment for the analysis.

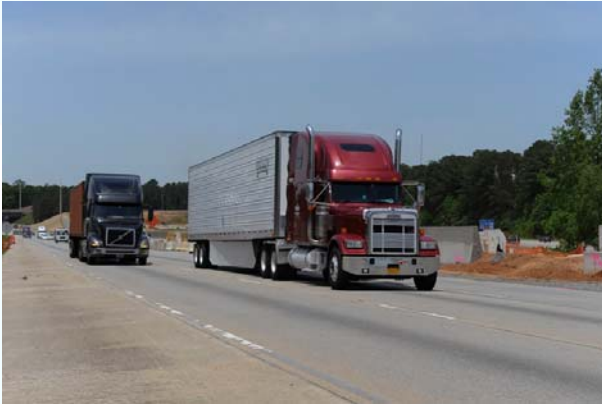
**Traffic**

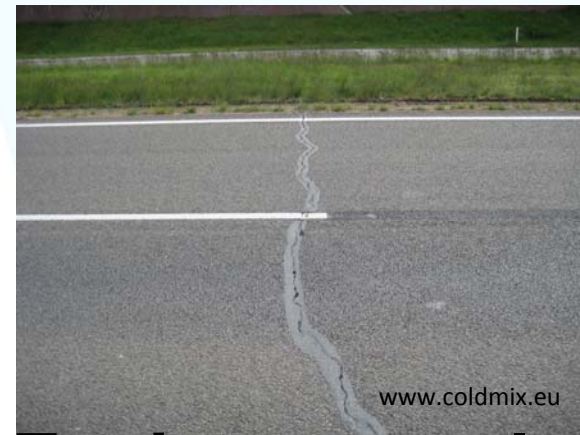
**Environmental  
Related Cracking**

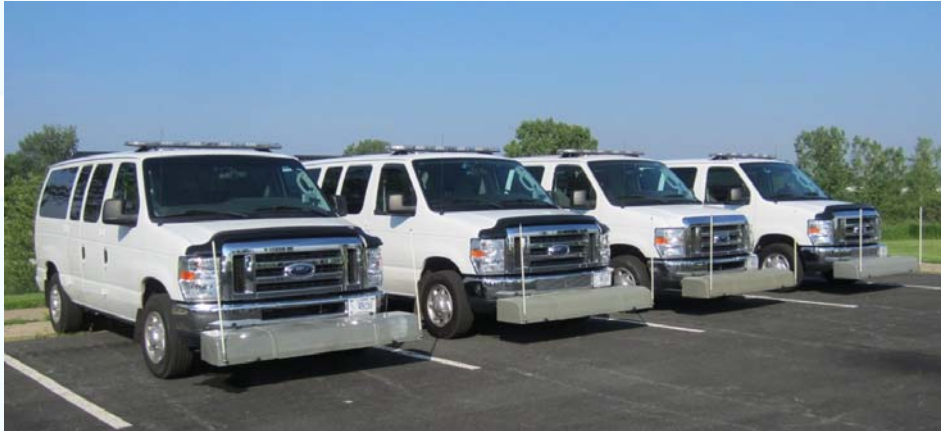
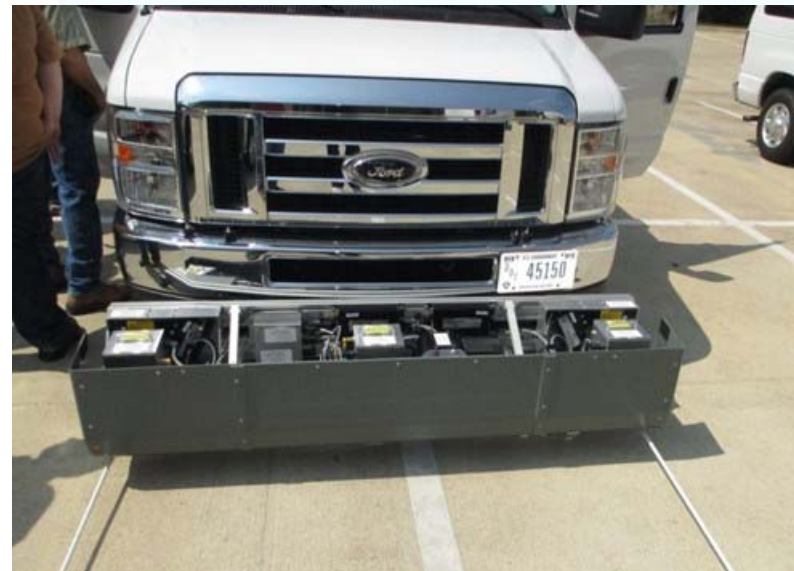
# LTPP Profilers

**Collecting Profile Data Along the Two Wheelpaths and Center of the Lane since 1996**

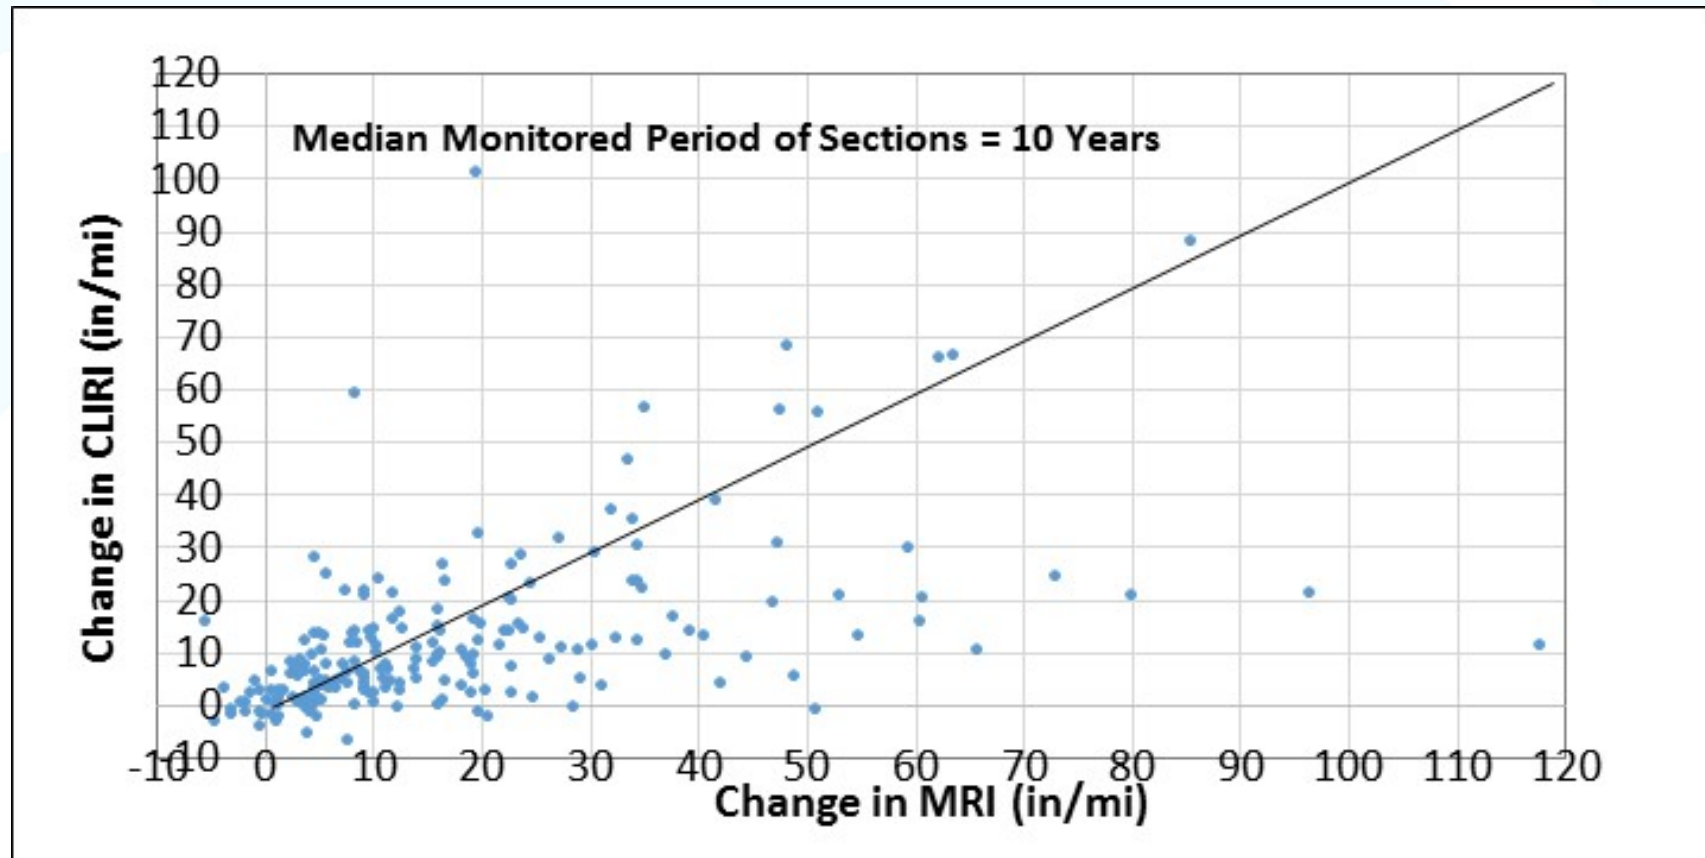
# CLIRI vs MIRI

Change in CLIRI > Change in MIRI at  
35% of Sections

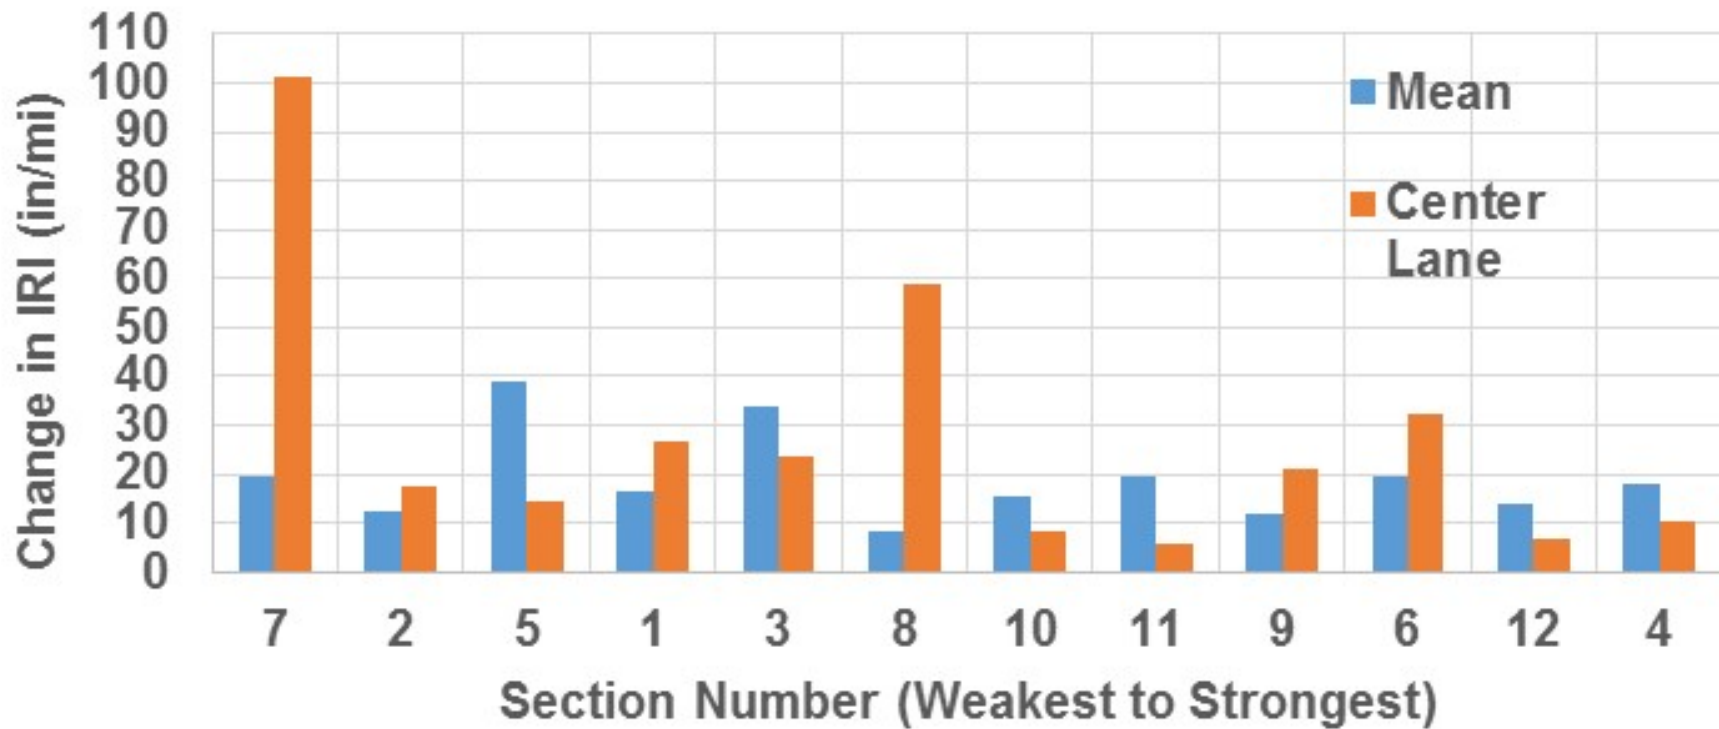
# Florida, Change in CLIRI and MIRI

Monitored Period: 15 Years, Subgrade: Corase-Grained

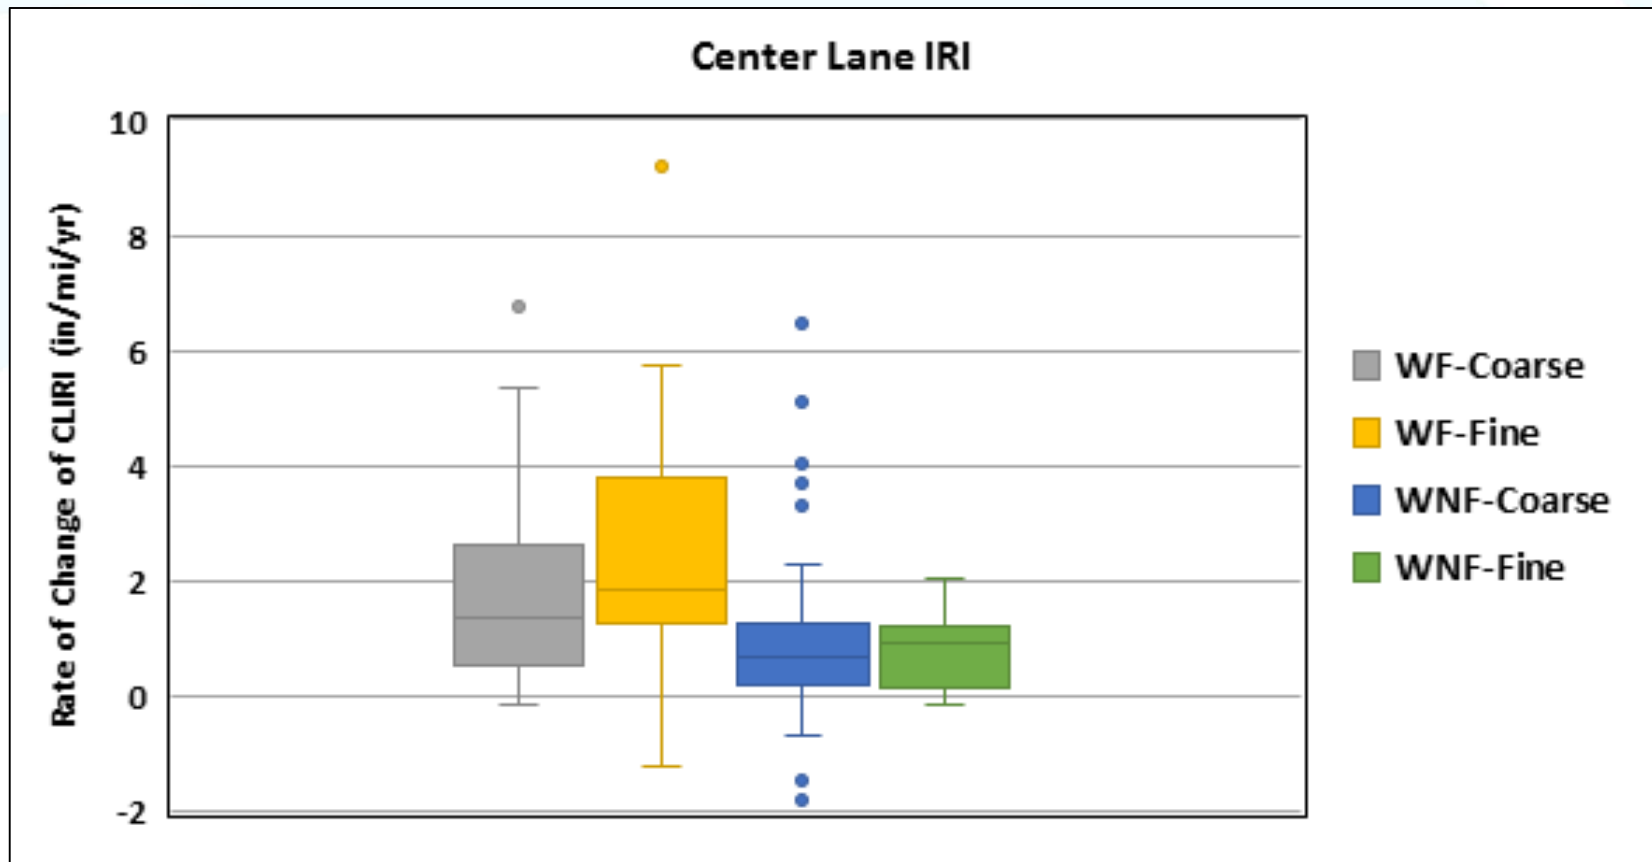
# Rate of Change of CLIRI, WF and WNF, Subgrade Type

- **Interaction of environmental effects and subgrade type affects roughness progression.**
- **Provision of drainage was shown to have a major impact on roughness increase for pavements on fine-grained subgrade in the wet-freeze zone.**

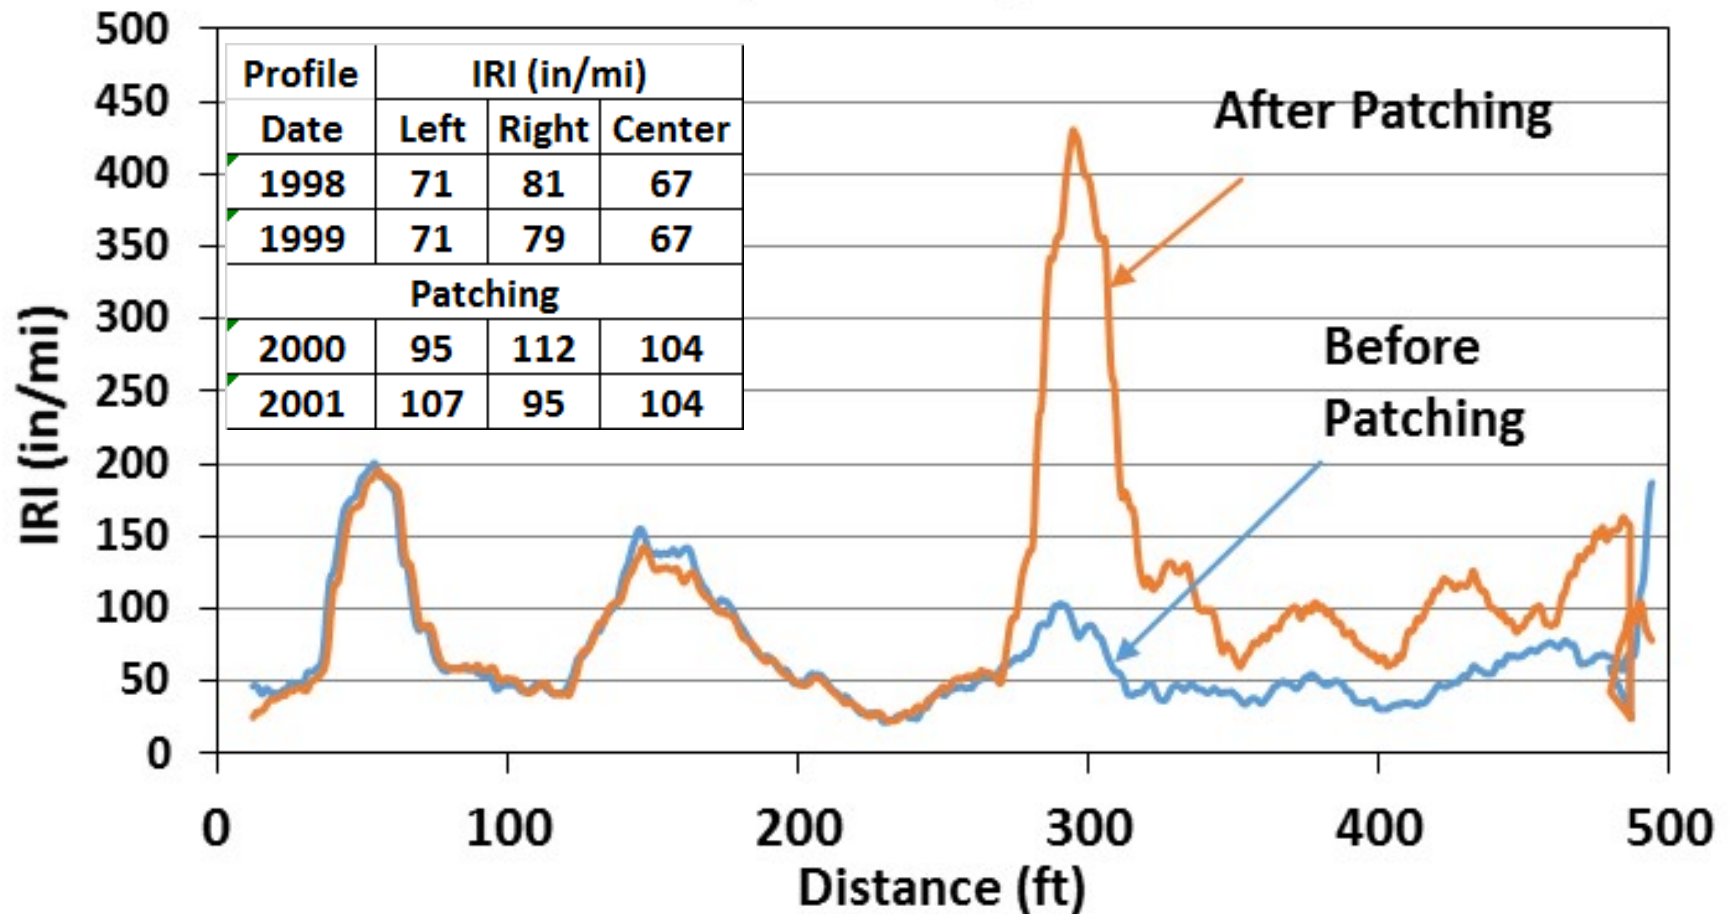
# 200106, Center Lane

Section 200106, Center Lane, Continuous IRI

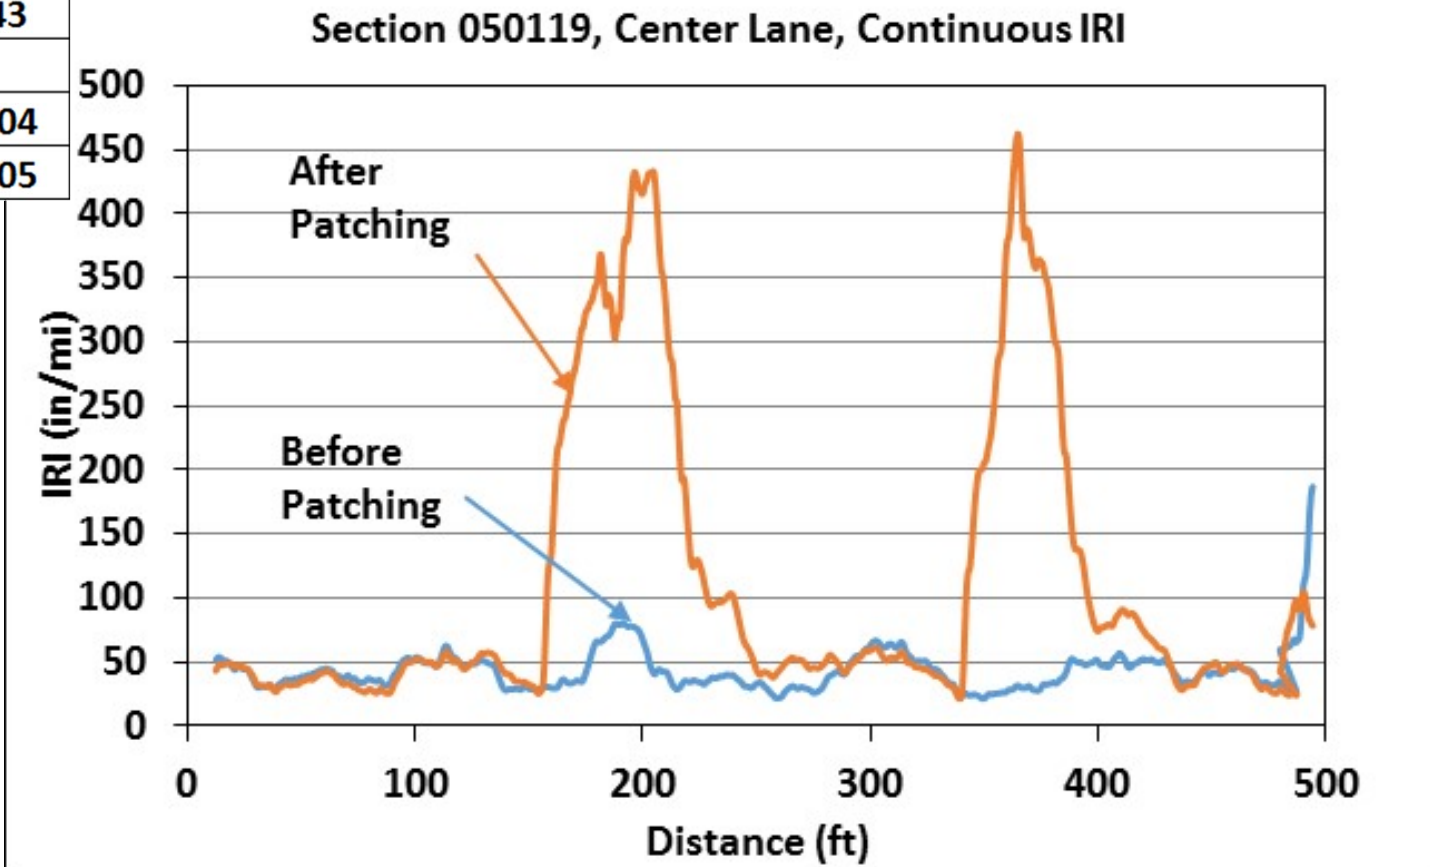
# 050119, Center Lane

Profile	IRI (in/mi)		
	Left	Right	Center
1997	53	51	43
1999	Patching		
2001	120	85	104
2002	121	85	105
